Conservation of the Wall Paintings in the Royal Tomb of Amenophis III

- First and Second Phases Report -

Joint Project of
Supreme Council of Antiquities, Ministry of Culture
Arab Republic of Egypt
and
Institute of Egyptology, Waseda University

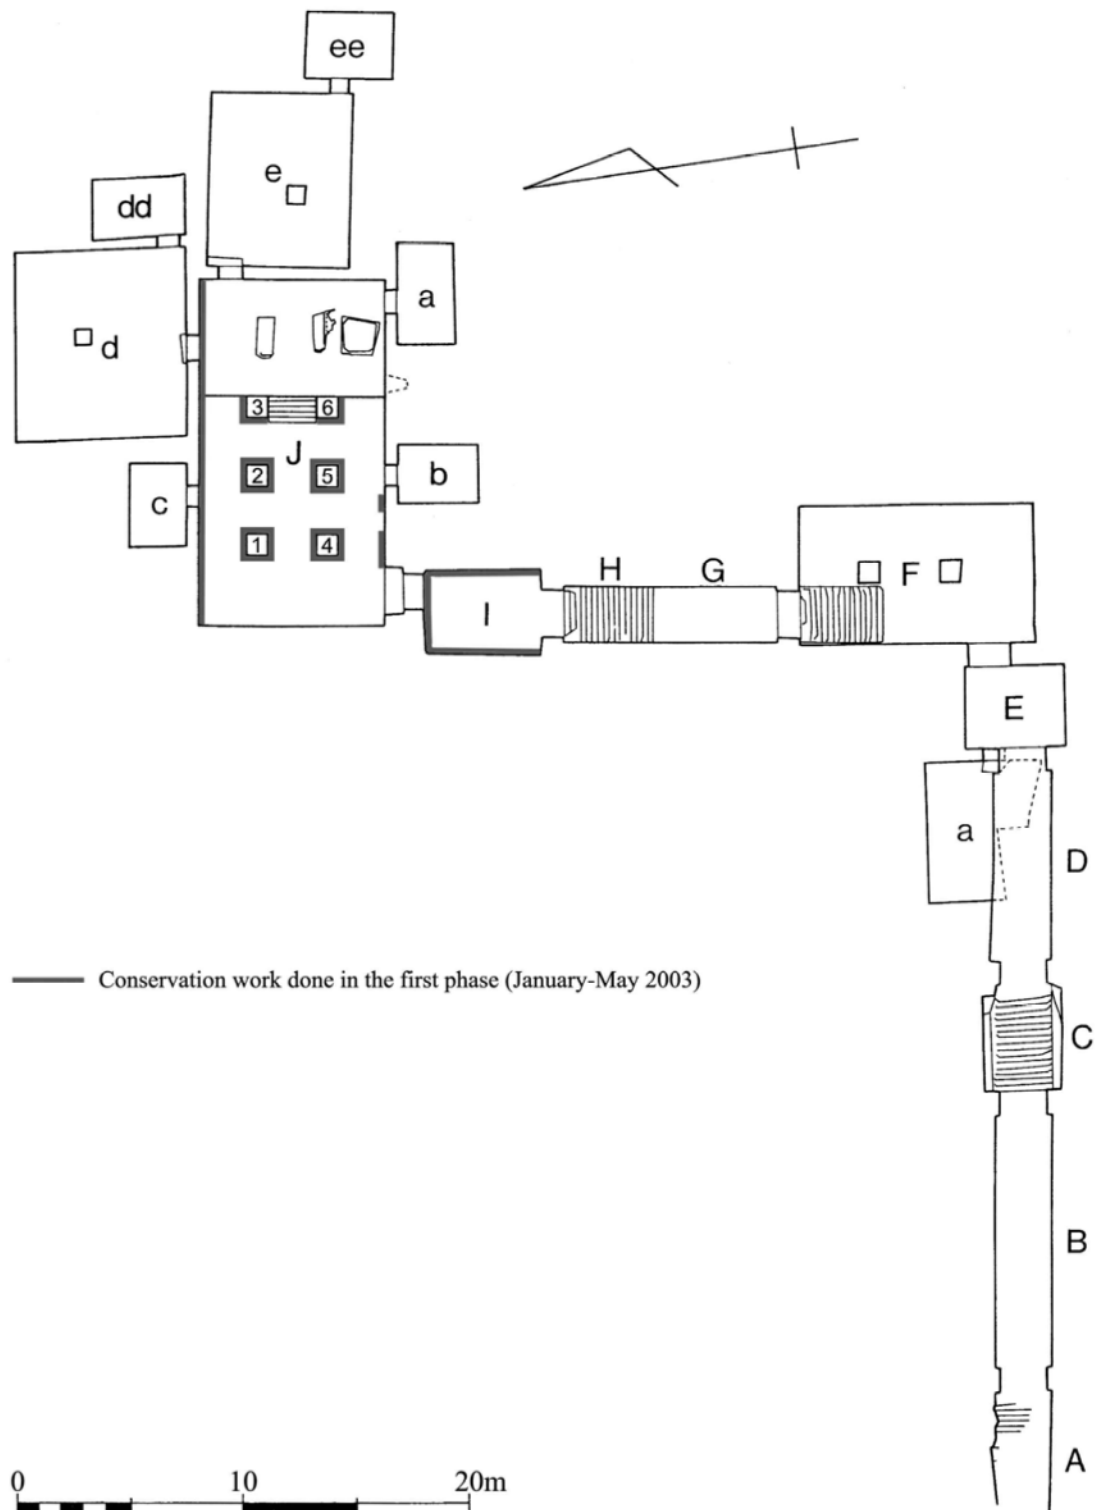
Fig.1 The plan of the royal tomb of Amenophis III (KV 22)

The royal tomb of Amenophis III is decorated with elaborate paintings of very high quality. Painted walls exist in room E (shaft chamber), room I (antechamber), and room J (burial chamber) (Fig.1). These chambers are decorated with the images of king and gods, and intricate hieroglyphic texts. The tomb paintings of Amenophis III are regarded as some of the most exquisite works of the royal tomb paintings in the Eighteenth Dynasty Egypt. The quality of these paintings, however, has been compromised by their precarious condition. Since their formal discovery by Napoleon's expedition in 1799, the wall paintings have never been taken care of or conserved. During the clearance of the tomb by our mission, the following undesirable conditions were observed.

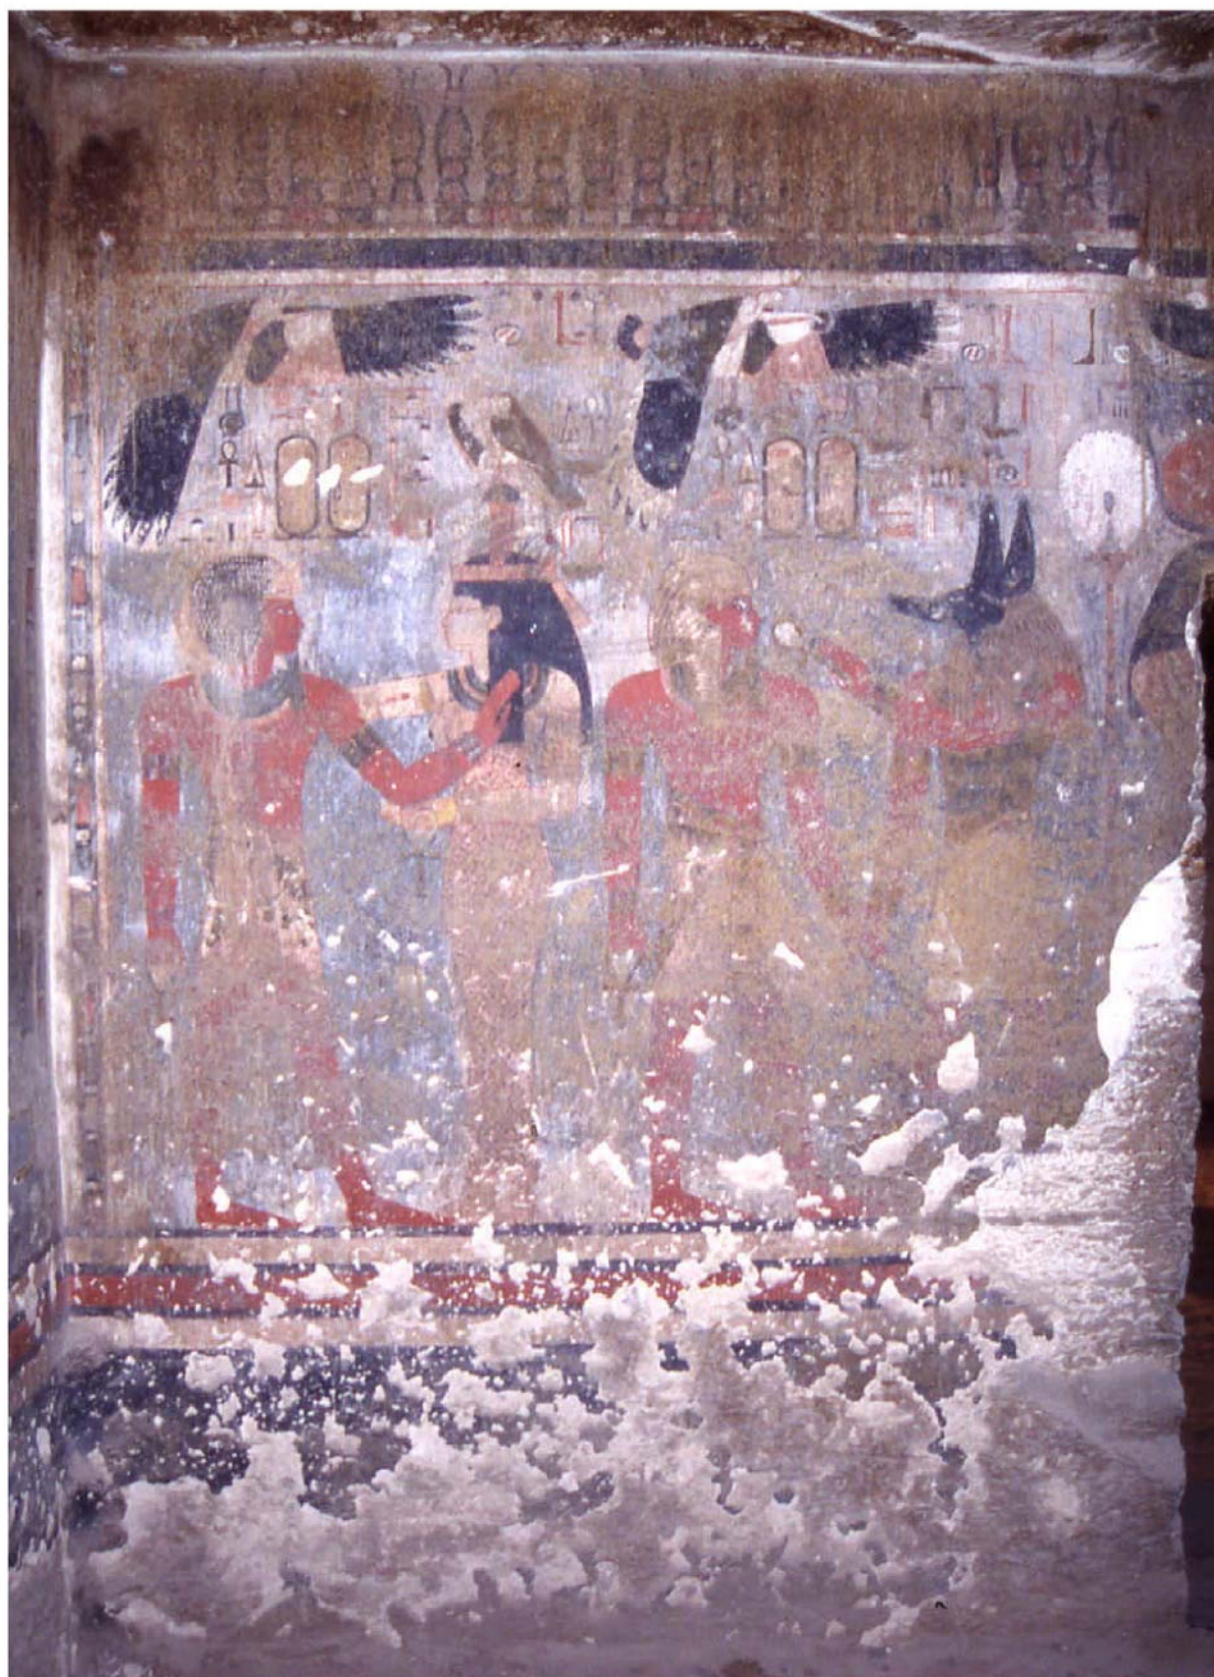
Fig.9 Room I north wall western part before conservation

The conservation work was started under the direction of Dr. Capriotti. Dr. Capriotti and Ms. Caterina Tocci had worked in the main decorated part of the wall of room I. Room I is decorated with exquisite wall paintings on its three walls, east, west, and north. The best preserved walls are the north wall and west wall; the east wall is mostly collapsed. These walls are stained by guano and bacteria, and some portion of the plaster was already collapsed, with the remaining part suffering from detachment. So far, the conservation of room I is almost finished except for the small sample areas

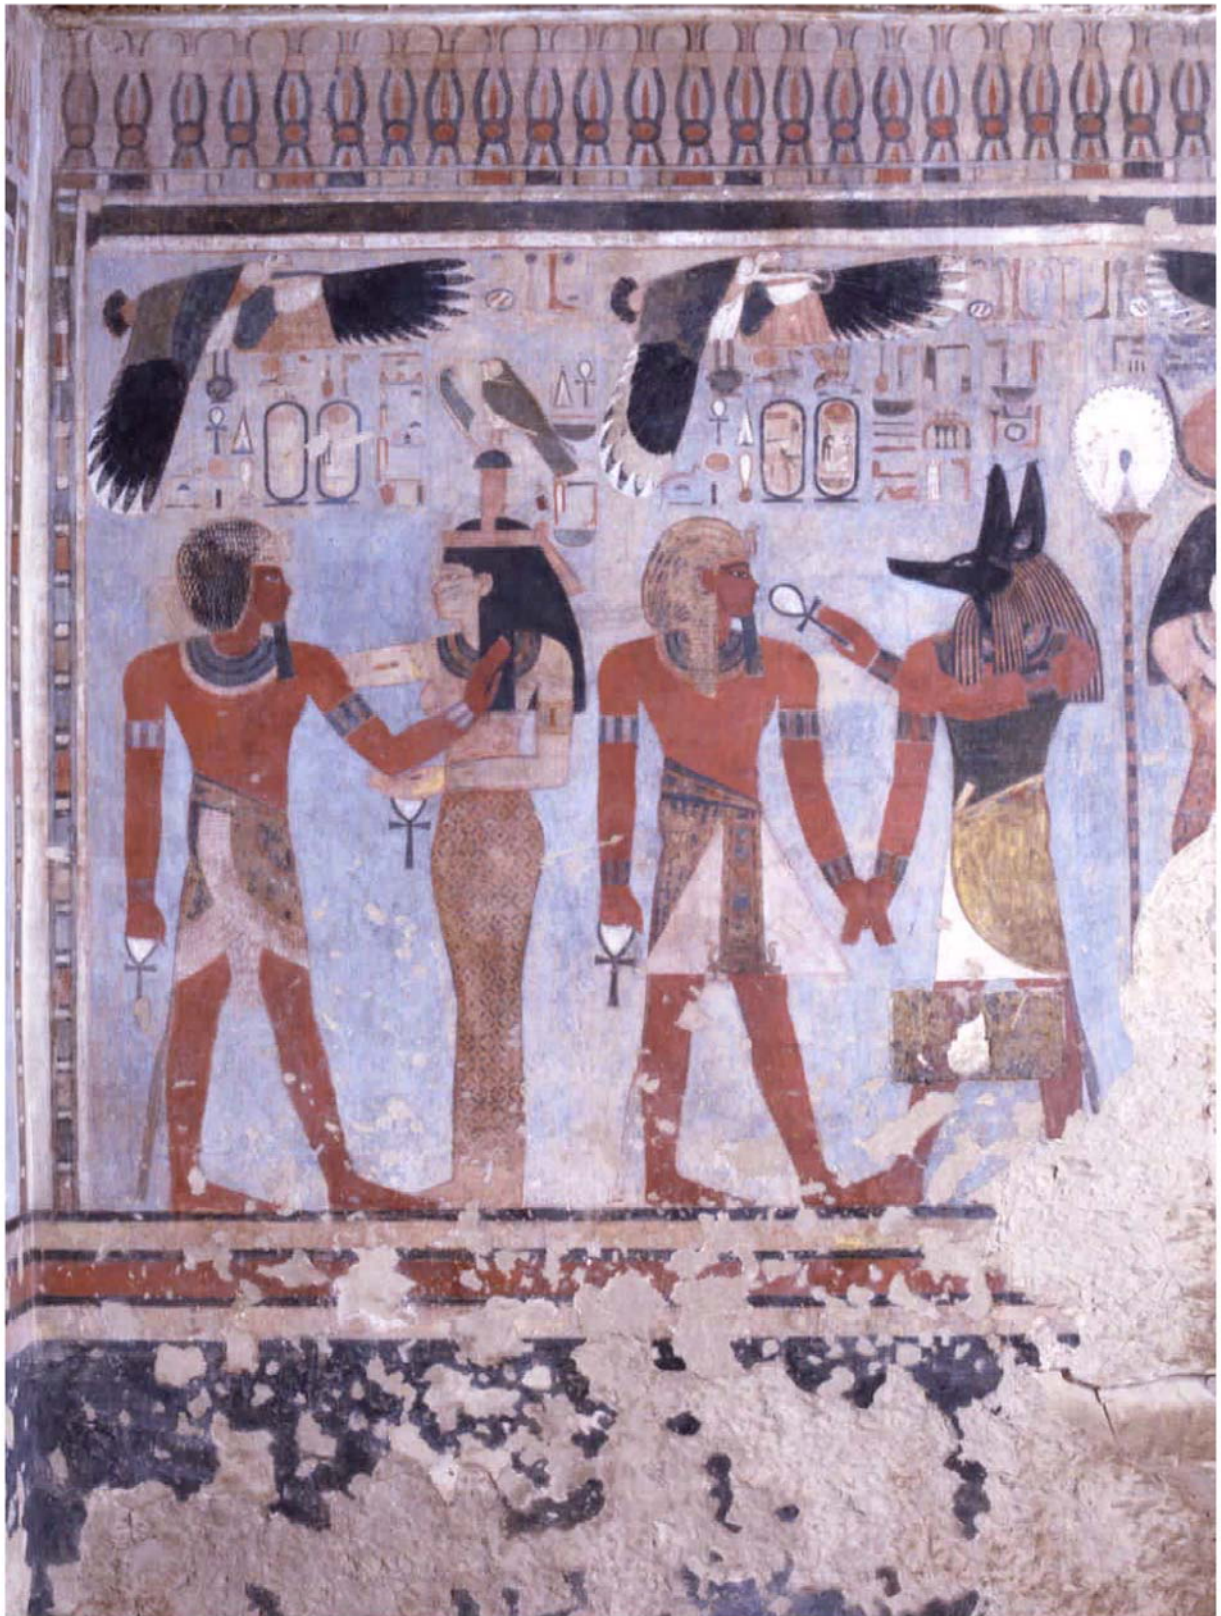
Fig.10 Room I north wall western part after conservation

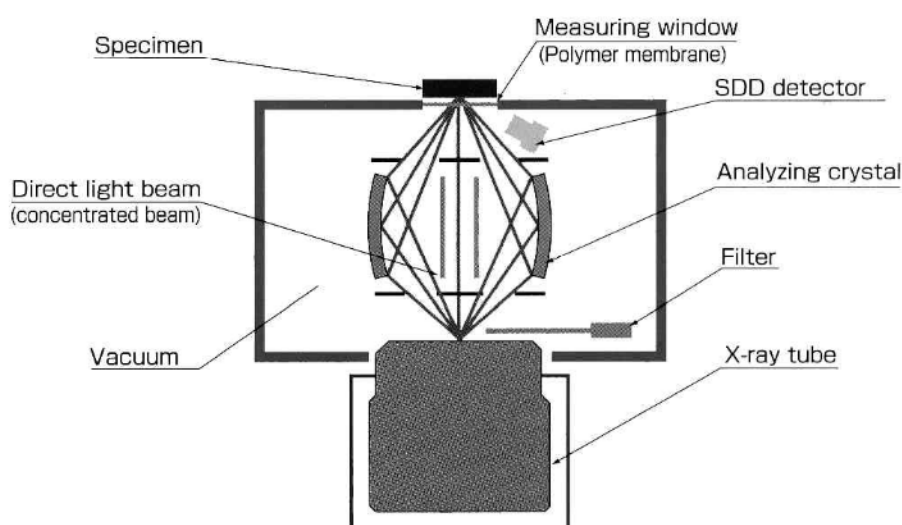
Fig.1 A schematic view of X-ray fluorescence spectrometer used in the tomb of Amenophis III

100 F commercially available from OURSTEX Corporation, shown in Fig.1, which is smallest in size, lightest in weight, and highest in performance in the world. The third one is an ED-XRDF (Energy Dispersive X-ray Diffraction and Fluorescence) spectrometer, which was specially designed and prepared by Waseda University and RIKEN KEIKI for this investigation. The same areas investigated by the OURSTEX 100 F and the ED-XRDF were also studied using the optical microscope, Picture Folder for VH-5000 (5 to 40 times in magnification) which has long focal length, i.e. 500 mm.

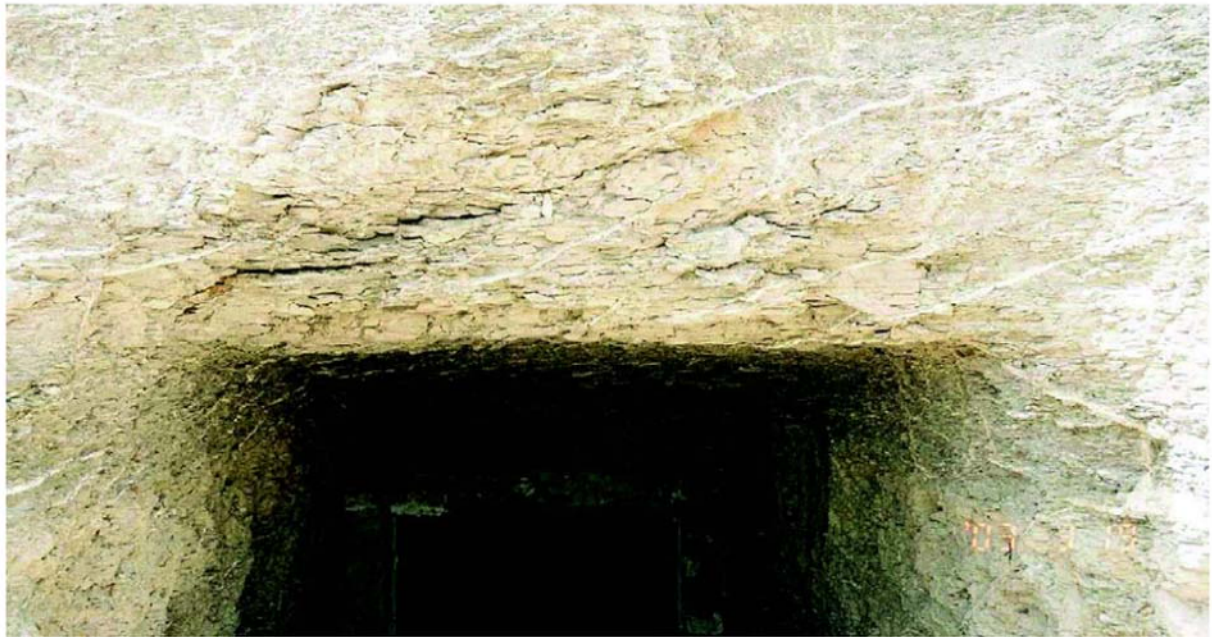
Fig.7 Entrance to underground tomb at Deir al-Bahri in Esna shale (note the fracturing and separation in the roof)

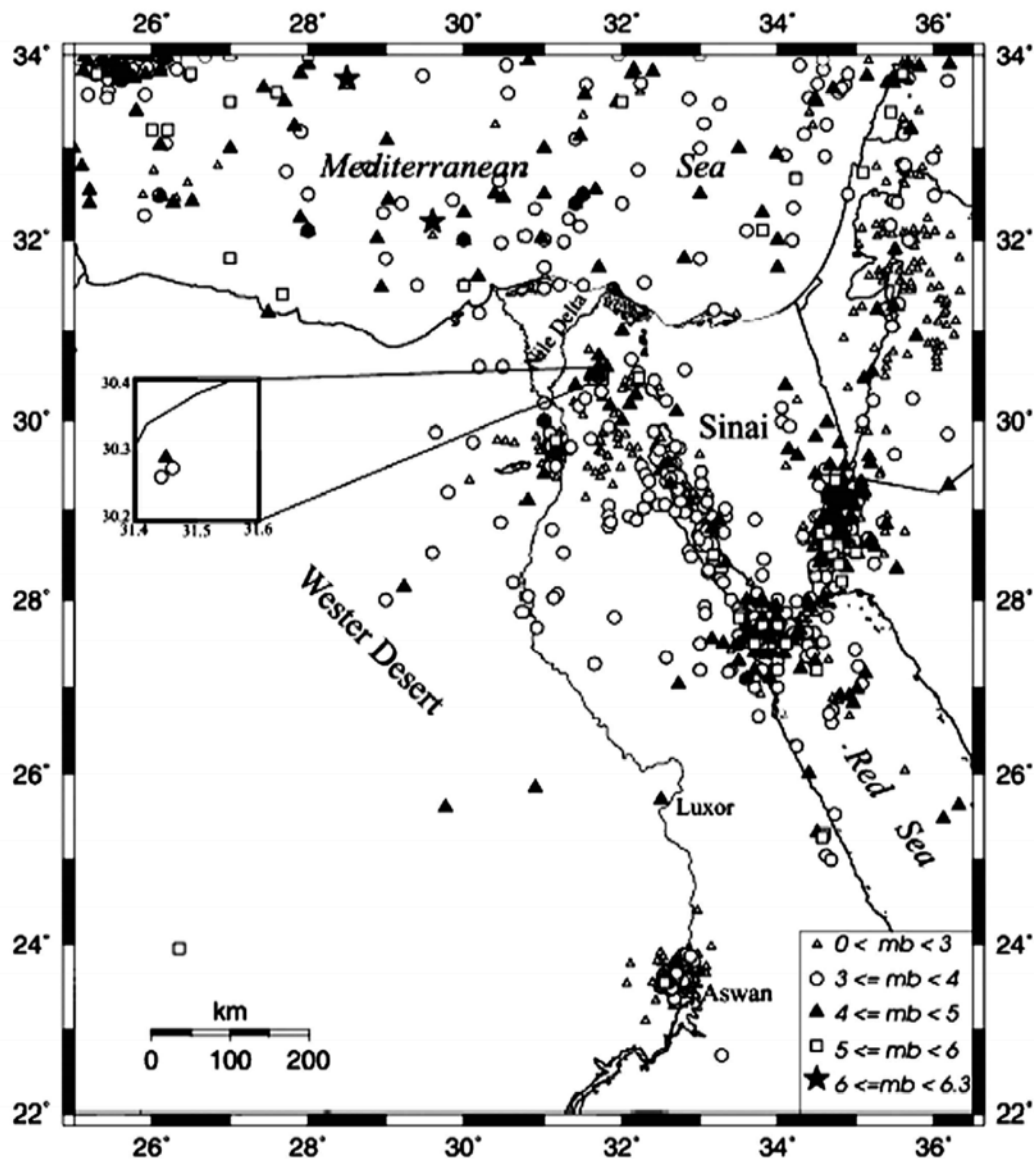
Fig.13 Epicenters of earthquake in Egypt and adjacent areas for 1900-2000 (after Badawy 2001)

different sources and results are shown in Fig.13. From these plots he drew the following conclusions:

Badawy (1991) plotted the epicenters of earthquakes between 1900 and 2000 compiled from

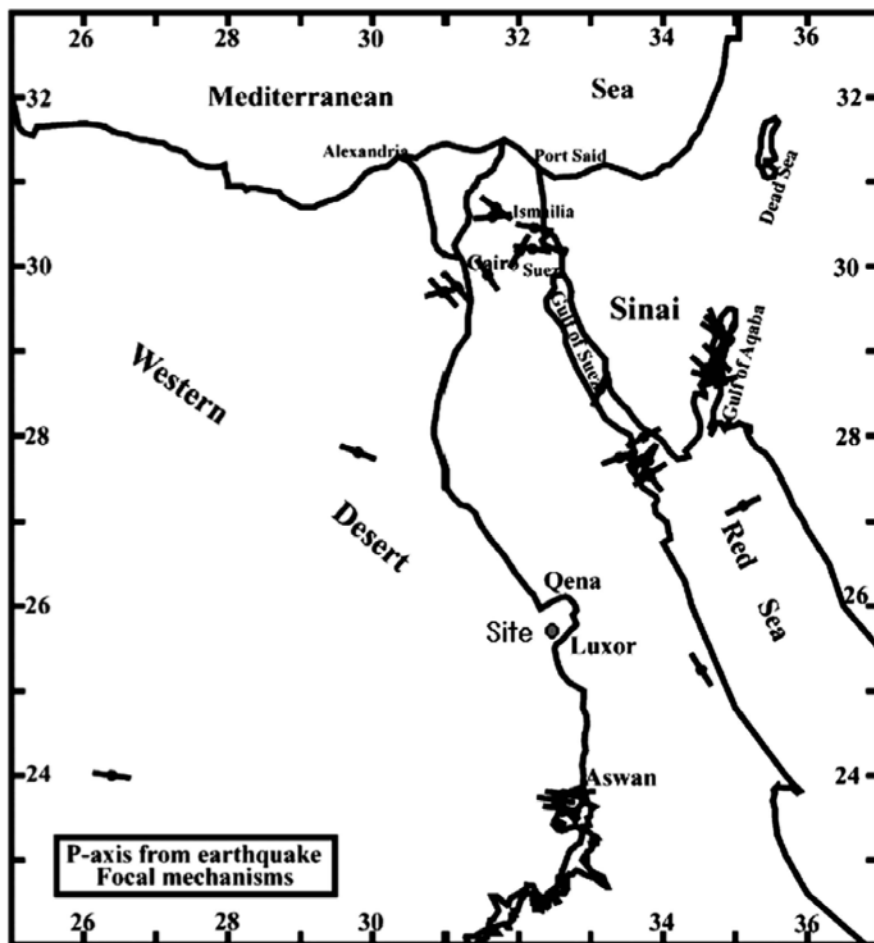
Fig.16 Inferred maximum horizontal stress directions from the focal plane solutions (modified after Badawy 2001)

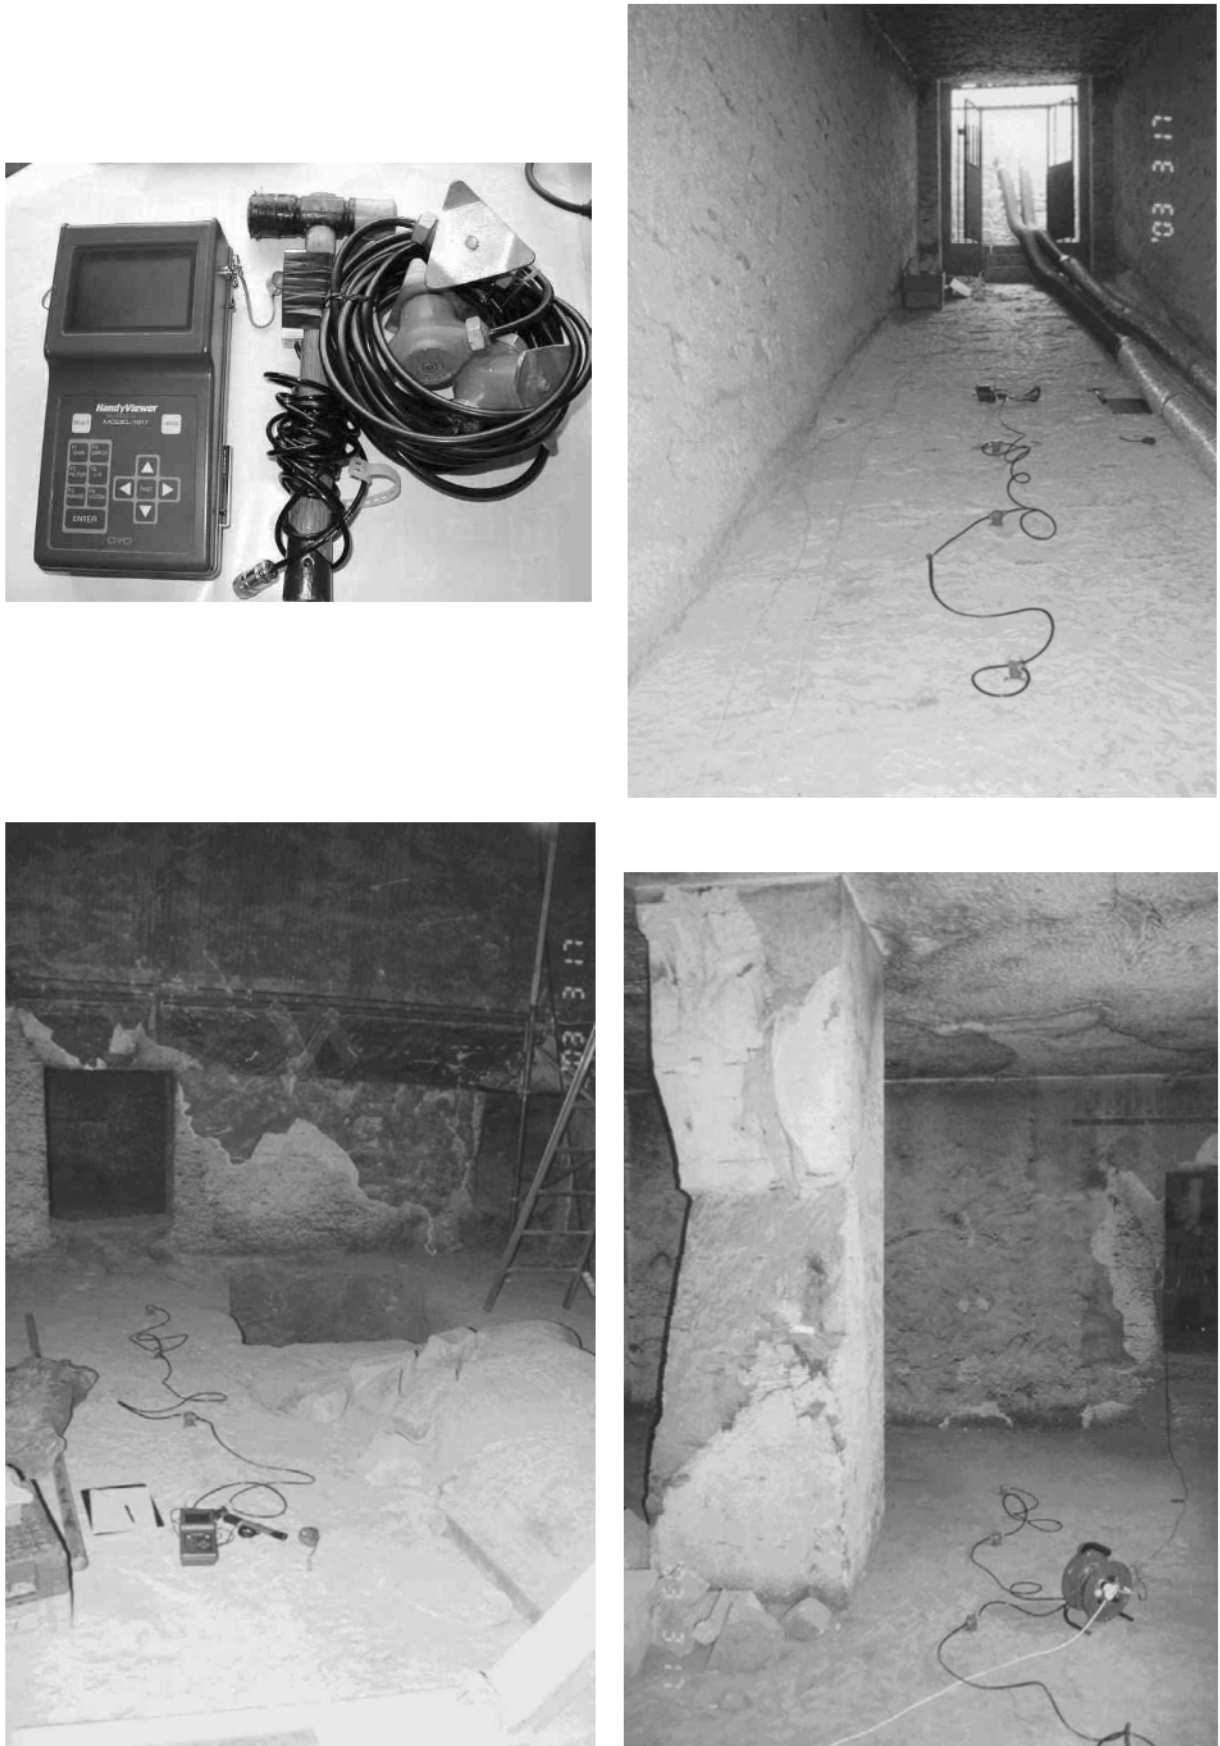
Room	Direction	Lowest Vp (km/s)	Highest Vp (km/s)
Je	N-S	0.862	1.139
Je	E-W	1.200	1.471
J	N-S	1.000	2.090
J	E-W	1.087	1.800
Jd	N-S	1.042	1.139
Jd	E-W	0.980	1.050
I	E-W	1.049	1.220
G	N-S	1.262	1.470
G	E-W	0.971	1.000
F	N-S	0.885	1.471
F	E-W	1.049	2.500
D-1	N-S	1.563	1.754
D-2	N-S	1.389	1.818
D-1	E-W	1.087	1.754
D-2	E-W	1.428	1.563
B	N-S	2.000	2.500
B-1	E-W	2.083	2.501
B-2	E-W	1.370	1.613
Jd-pillar-1	Vertical	2.549	3.399
Jd-pillar-2	Vertical	2.195	2.358
Jd-pillar-3	Vertical	1.611	2.712
F-pillar1-1	Vertical	1.857	3.064
F-pillar1-2	Vertical	1.767	2.371
F-pillar2-1	Vertical	1.652	1.867

Fig.25 Some views of measurements and instruments

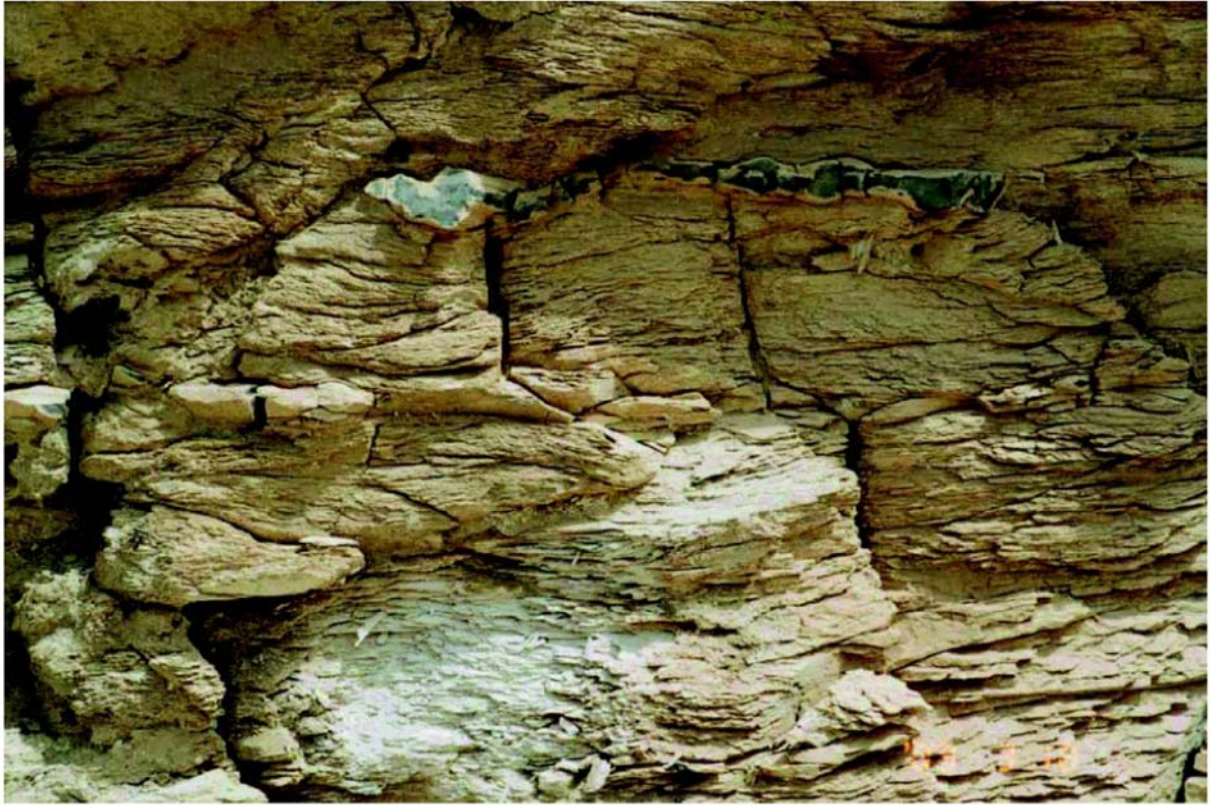
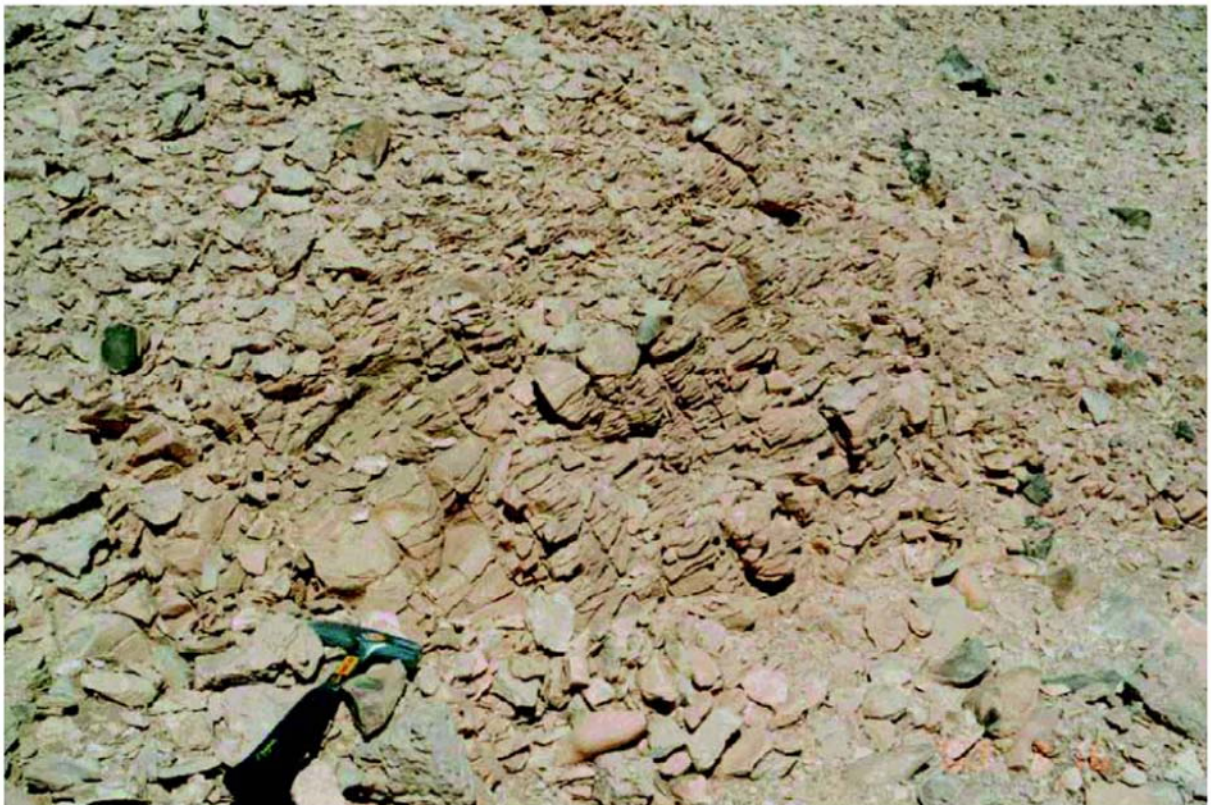
Fig.28 Two views of weathered soft limestone near the entrance of the tomb

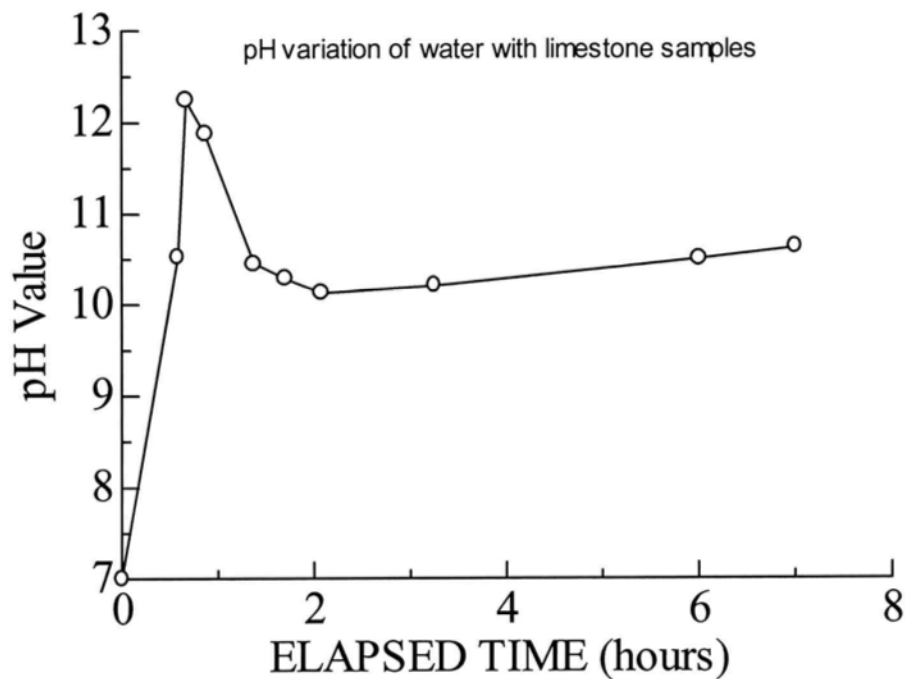
Limestones in the vicinity of the tomb are classified into soft limestone and hard limestone. The soft limestone contains clay. It is therefore expected that it will interact with water, and its physical and mechanical characteristics are expected to be greatly influenced by its water content. On the other hand, the effect of water is expected to be negligible on hard limestone, which is almost crystalline. Samples were put into a water container and were submerged in local tap water, whose pH value was 7.00. The samples were kept submerged for more than 48 hours until they were subjected to the drying process in order to investigate their water migration characteristics. When dry samples were submerged in water, it was quite interesting to note that some sounds are audible for a period of about 2 hours. The pH value of water was measured for about 8 hours as shown in Fig.35. As seen in the figure, the pH value increases rapidly and becomes stabilized after 2 hours. However, the pH value had almost returned to its initial value after 48 hours. Additionally, stirring the water could cause some increase in the pH value, which implied that the solved calcium ions had settled on sample surfaces or at the bottom of the container.

Fig.35 pH value of water in which samples were submerged

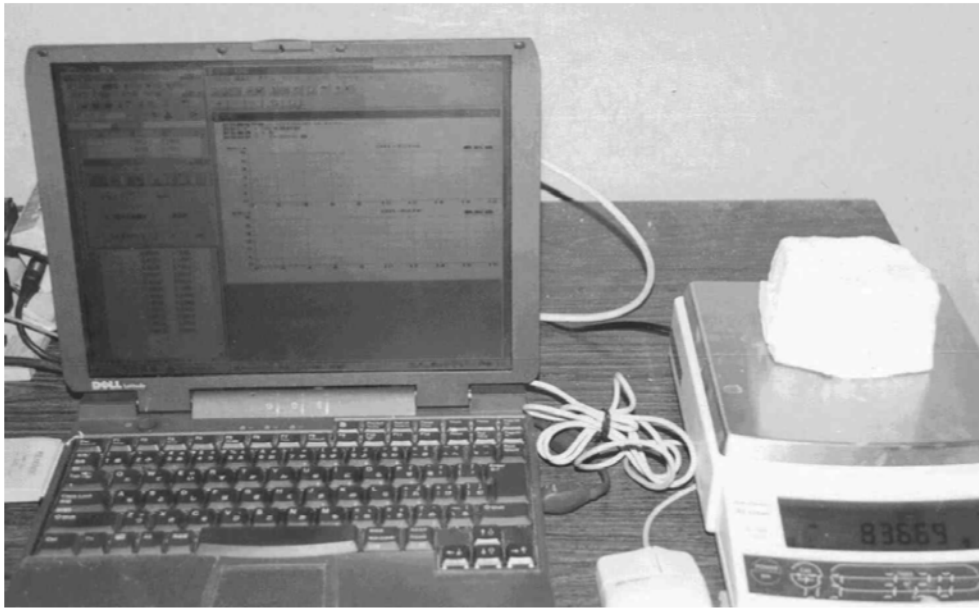
A total of 6 samples were tested. One of them was hard limestone while the rest of the samples were soft limestone. Samples were air-dried, as shown in Fig.36. The temperature and humidity of the room in which the samples were tested were recorded automatically at a sampling rate of 1-minute (Fig.37). The temperature and humidity variations were limited to 3°C and 15% throughout the tests. Fig.38 and Fig.39 show the variation of water content of samples of hard limestone and soft limestone. The functions calculated by the respective figures will be used to obtain the water content migration coefficients of rock type using a procedure proposed by Aydan (2003).

Fig.36 A view of drying test for water content migration characteristics

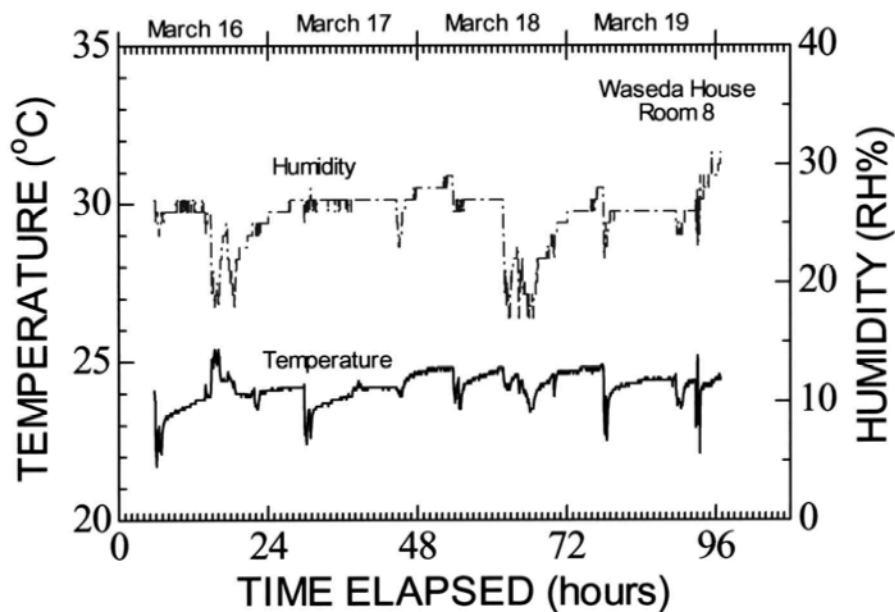
Fig.37 Variation of temperature and humidity of room 8 during drying tests

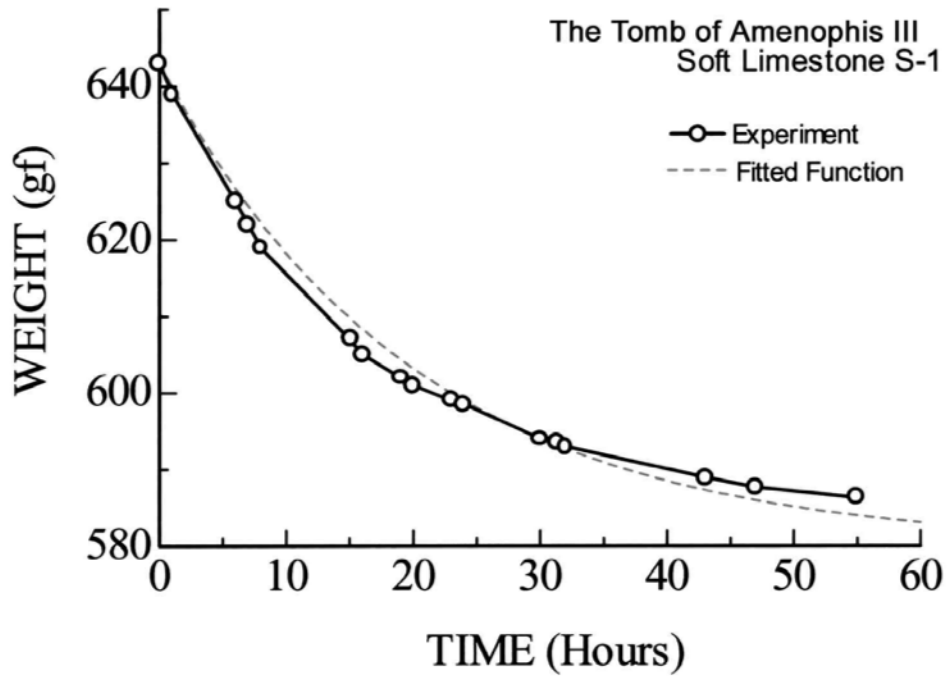
Fig.38 Variation of weight of soft limestone sample 1

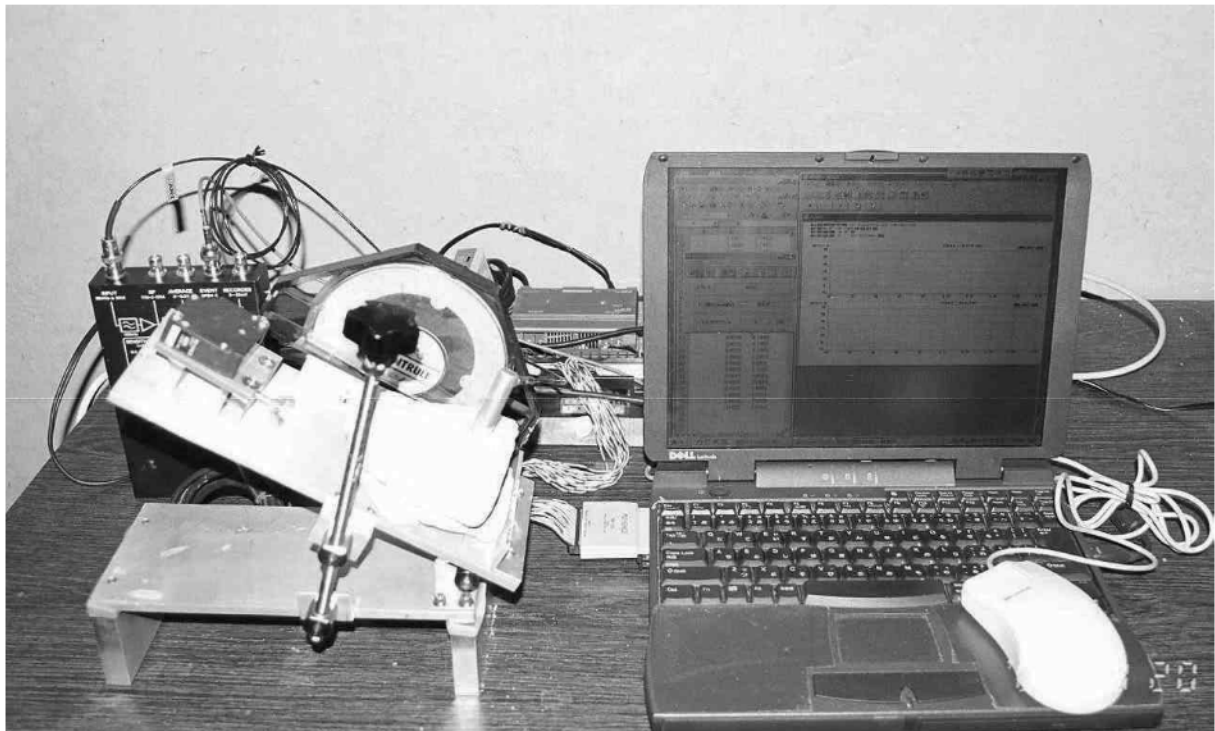
The mechanical behaviour of discontinuities existing in rock mass is of great concern when the stability analyses are carried out. For this purpose, some laboratory and *in situ* shear tests were required. Because of the historical value of the tomb, it was extremely difficult to perform such tests. To obtain the frictional characteristics of discontinuities, some tilting tests, which were unlikely to damage the specimens, were carried out on some from fallen rock specimens of non-historical importance and outside outcrops. Fig.40 shows a view of such tests. The portable tilting test device was specially developed for this particular purpose. A laser displacement transducer was mounted to measure the tilting angle and relative displacement of the upper block. In addition, an acoustic emission (AE) sensor was mounted on the tilting device to measure the AE response of discontinuities during the test. Fig.41 shows an example of measured responses during a tilting test. Tests were carried out on several types of rock discontinuities and the results are summarized in Table 5.

Fig.40 A view of the tilting test

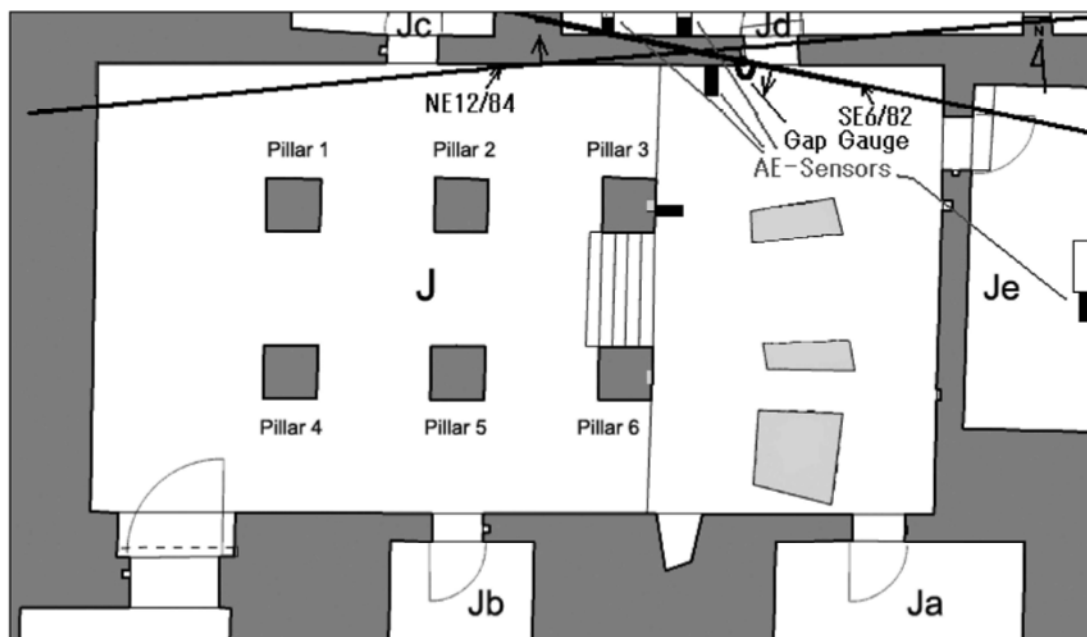
The investigators were concerned with the *in situ* performance of surrounding rock mass since there are some instability problems in the tomb. The earlier reports (i.e. Tanimoto et al. 1993) claimed that there was a creep-induced failure at the pillar of room Je. The investigators were quite concerned with this pillar regarding its long-term behaviour. However, the investigations on the first day clearly indicated that the pillar was already unstable at the time of excavation of the tomb. After some careful observations, it was identified that the wall between room J and room Jd was in critical condition concerning the overall stability of the tomb in the vicinity of room J and adjacent rooms such as Je, Jc and Jd. Acoustic emission monitoring units consisting of acoustic emission sensors together with their amplifiers and loggers were installed at the wall between room J and room Jd, at the pillar of room Je and at pillar 3 of room J (Fig.42). In addition, a displacement gap gauge was installed at the same wall together with amplifier and logger units. Fig.43 shows some views of the installation locations of acoustic emission measurement units. Fig.44 shows a view of the displacement gap gauge installed at the crack crossing the north wall of room J adjacent to room Jd. During 4 days of observations, no acoustic emission signals were observed except some superficial signals caused by other operations in the tomb. The displacement gap gauge presently seems to be responding to the temperature fluctuations. Temperature and humidity sensor in room J has been re-located nearby the acoustic emission sensors and displacement gap gauge in order to know the variations of temperature and humidity in room J and adjacent rooms Je and Jd.

Fig.42 Location of AE sensors and displacement gap gauge

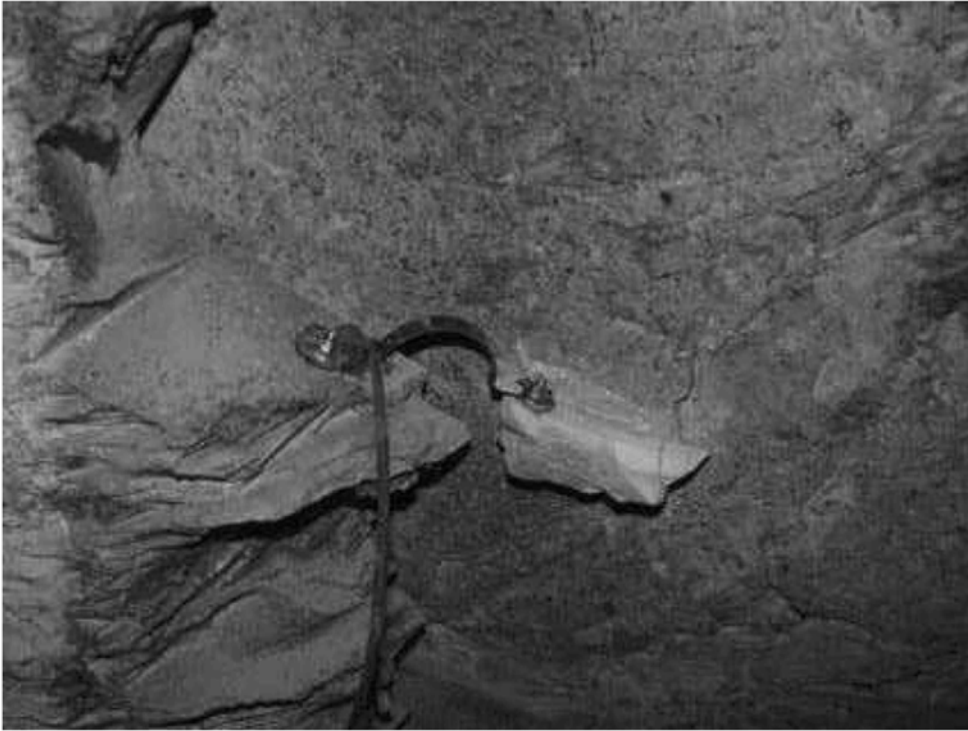
Displacement gap gauge at the crack on the north wall of room J

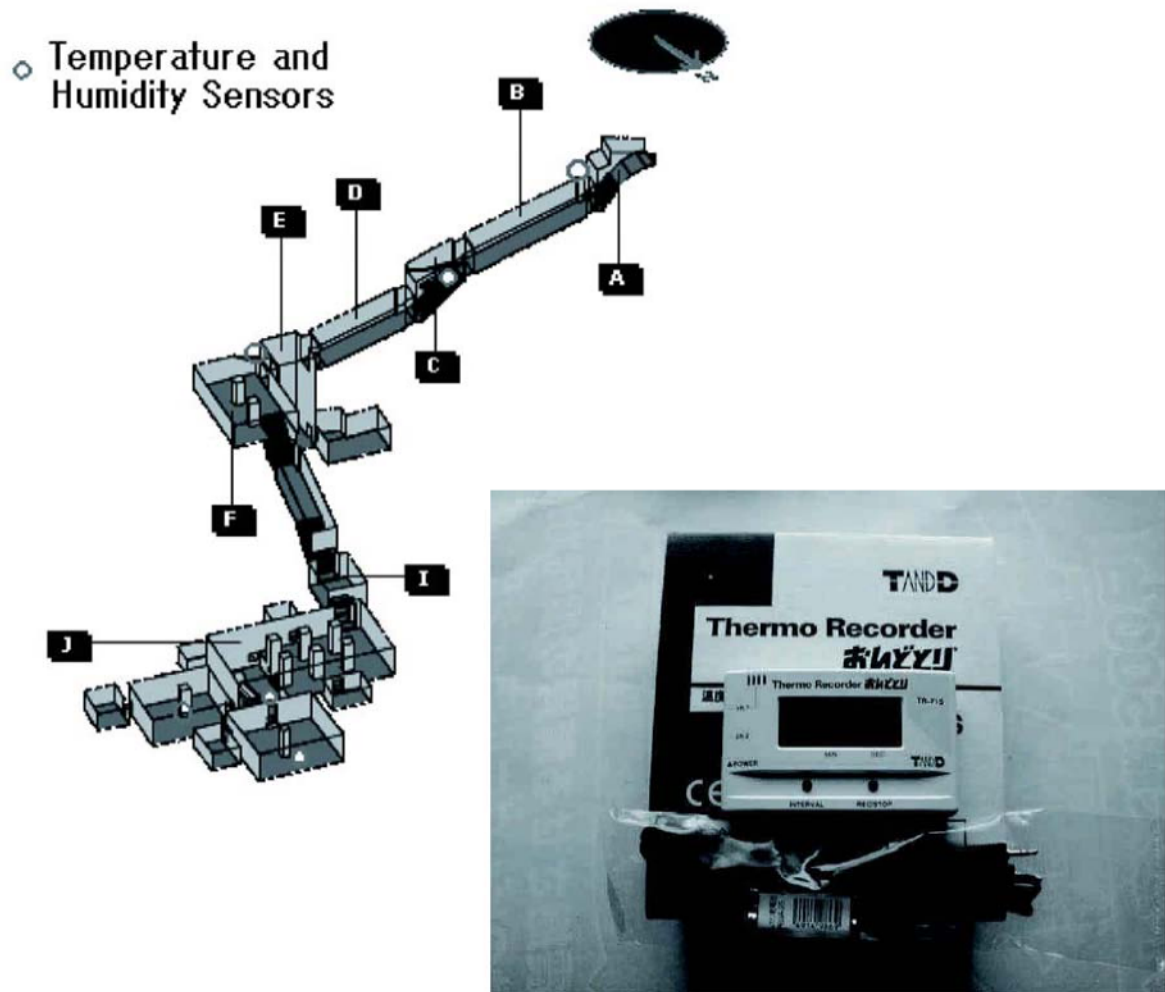
An environmental *in situ* measurement system concerning temperature and humidity variations in the tomb has been installed and it is in operation since March 17, 2003. Temperature and humidity sensor and logger units produced by TANDS shown in Fig.45 have been installed at 6 different locations. Fig.46 shows views of some installation locations. The measurements were carried out at a sampling rate of 30 seconds for four days to see if there were rapid variations of temperature and humidity in the tomb. Fig.47 shows the records for the first day and second day. Since the variations were small after the first trials, the sampling rate has now been set to 1 hour and it is expected to record the temperature and humidity until Feb. 16, 2004. Furthermore, a rainfall observer was installed at the roof of Waseda House to monitor the rainfall in the vicinity of the tomb and Luxor. Fig.48 shows a view of the rainfall observer.

Fig.45 Location and a view of temperature and humidity sensors and logger

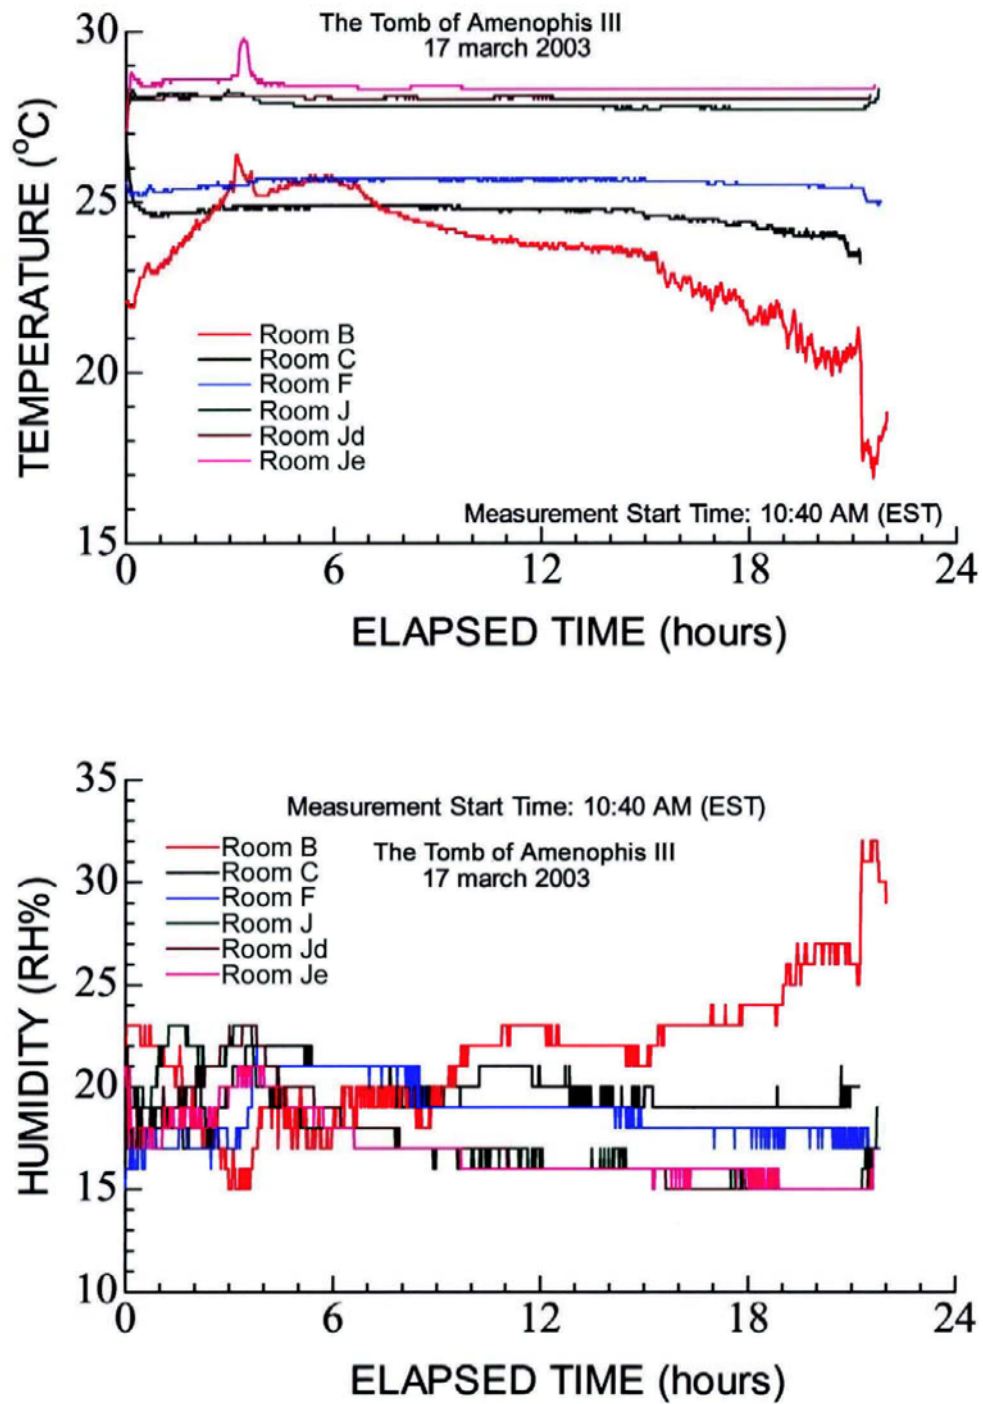
Fig.47 Temperature and humidity variations with time at the tomb of Amenophis III
