Conservation of the Wall Paintings in the Royal Tomb of Amenophis III

- First and Second Phases Report -

Joint Project of
Supreme Council of Antiquities, Ministry of Culture
Arab Republic of Egypt
and
Institute of Egyptology, Waseda University

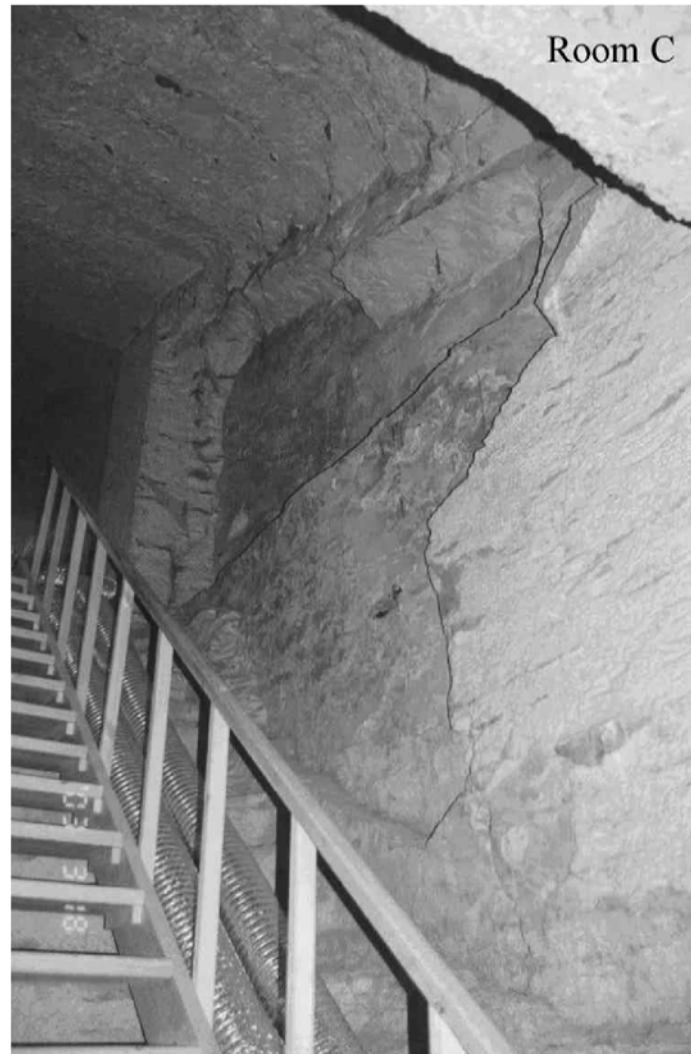
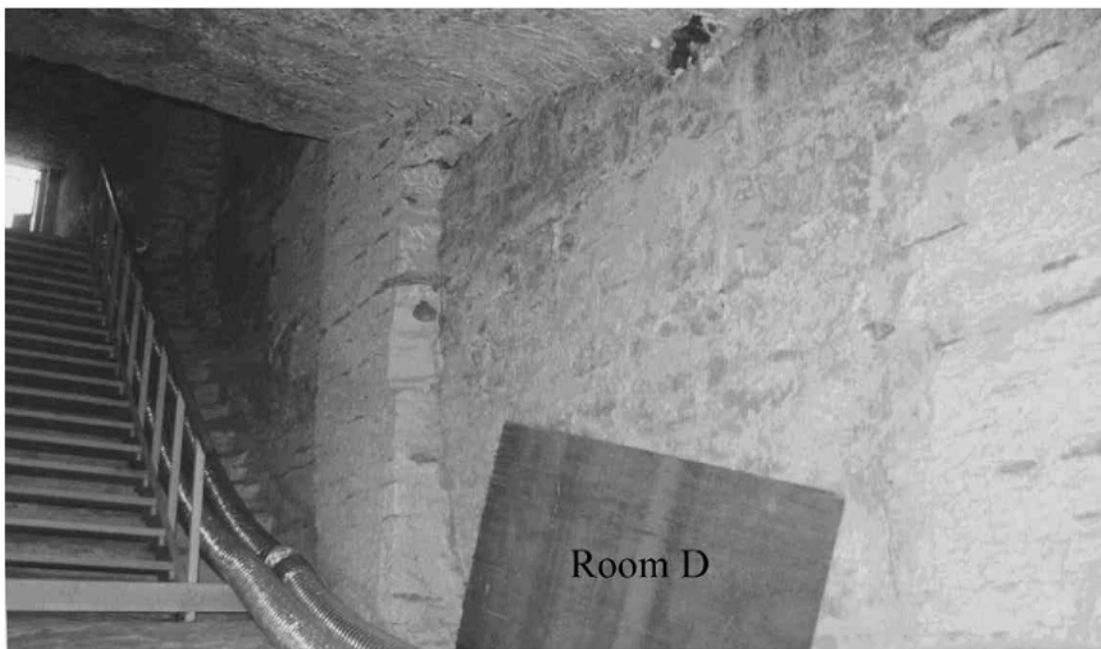
Fig.49 Toppled slabs at room C and room D

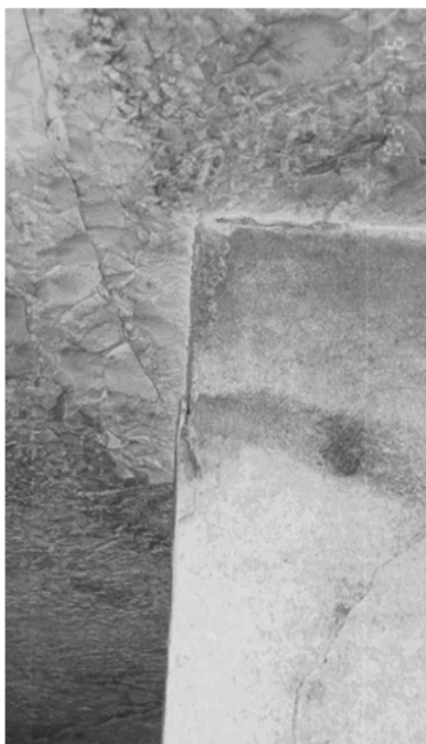
Close-up view of SW corner

Fig.50 Views of fractured pillar of room Je

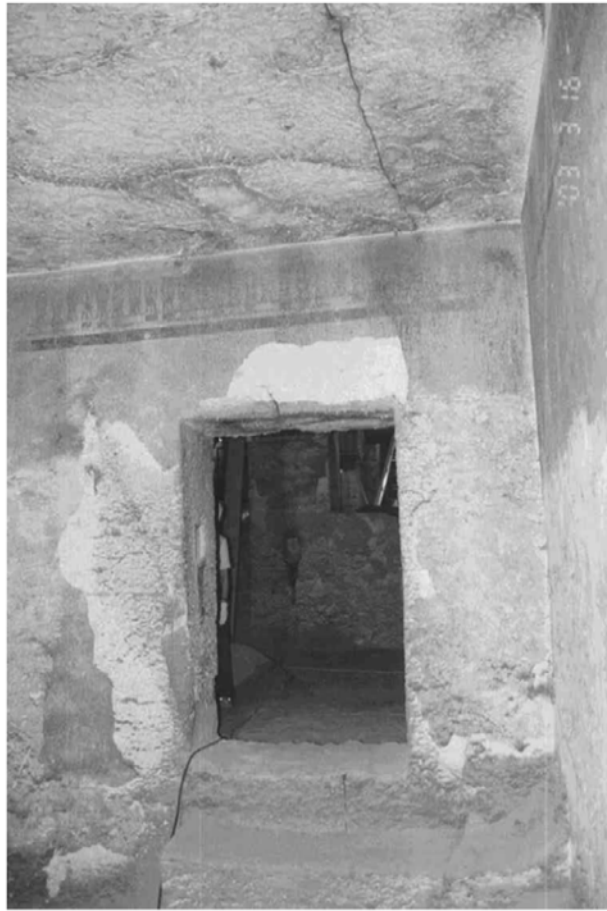
NW corner of room Je. Plaster tends to fall due to new fracturing and wall deformation

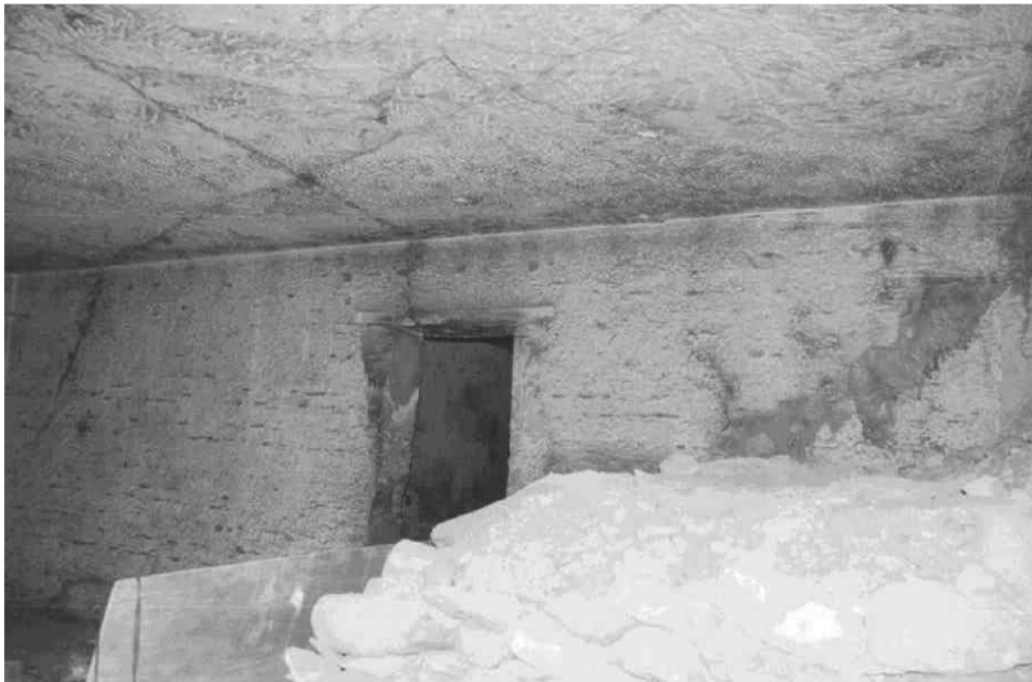
Room J	Wall fracturing	The wall adjacent to room Jd has two pre-existing discontinuities. The discontinuity (NE12/84) was continuous and the discontinuity (SE2/82), which is stepped and sub-parallel to the wall, joined up. The wall is presently splitting and requires urgent reinforcement measures. The wall between room Je has also some new fractures, but its state is better than the wall adjacent to room Jd.
Room J	Pillar splitting fractures	Pillars 1, 2 and 3 have some vertical or sub-vertical splitting fractures. There is a detached piece of split fragment at the SE corner of pillar 3, which is temporarily supported. The east side of pillar 2 split and it had fallen off. Pillar 1 also has split and fallen-off corners. Pillars 4 and 5 have some splitting cracks, while pillar 6 is free of cracks. It is thought that pillars 1, 2 and 3 were subjected to high loads due to failing pillar wall between room J and room Jd.

Fractured wall between room Jd and J

Fig.51 Fractured walls between room J and adjacent room Je and Jd

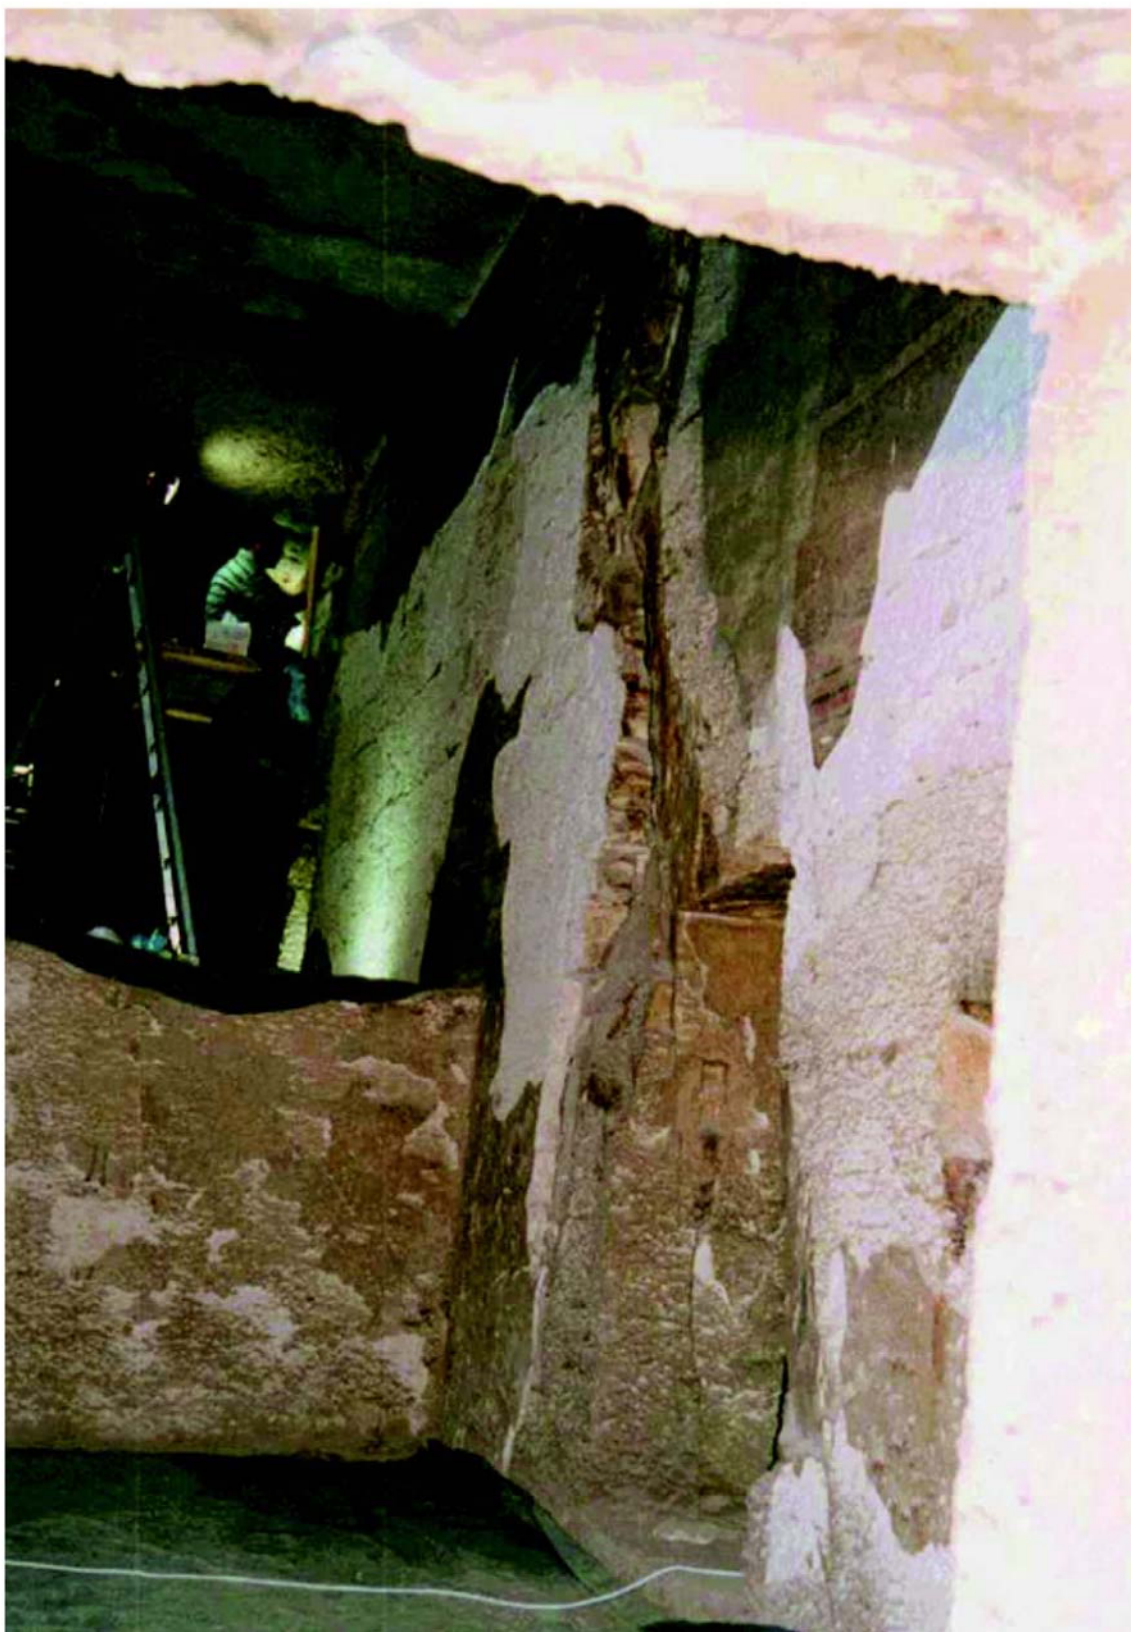
Fig.52 The state of the north wall of room J

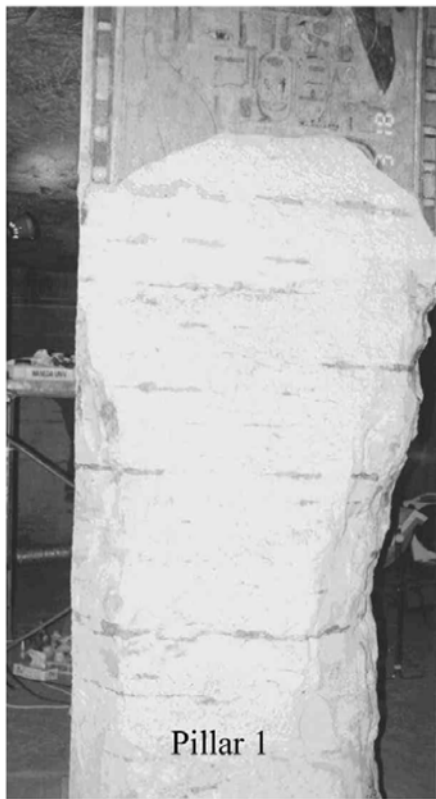
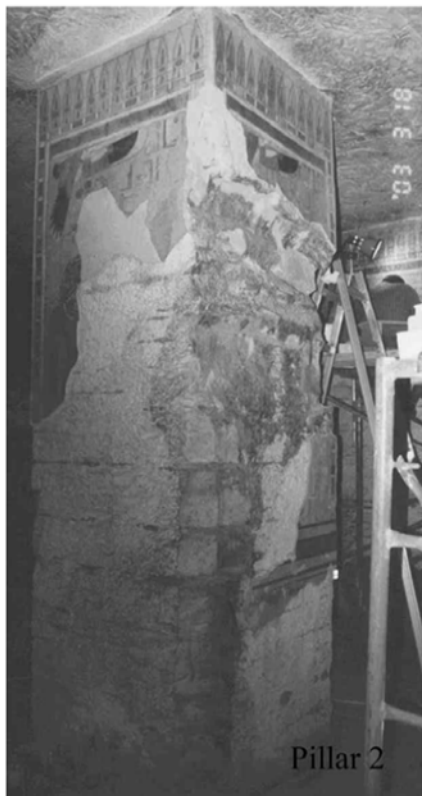
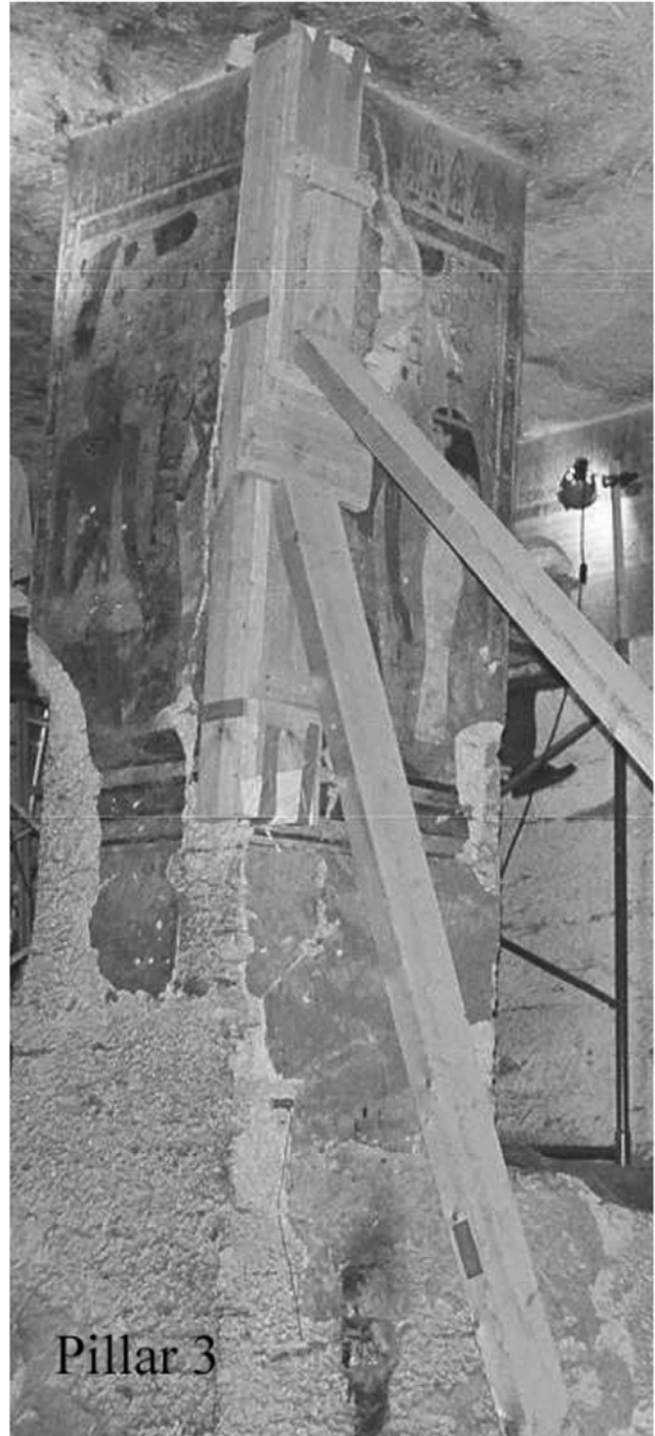
Fig.53 Views of pillars 1, 2 and 3 in room J

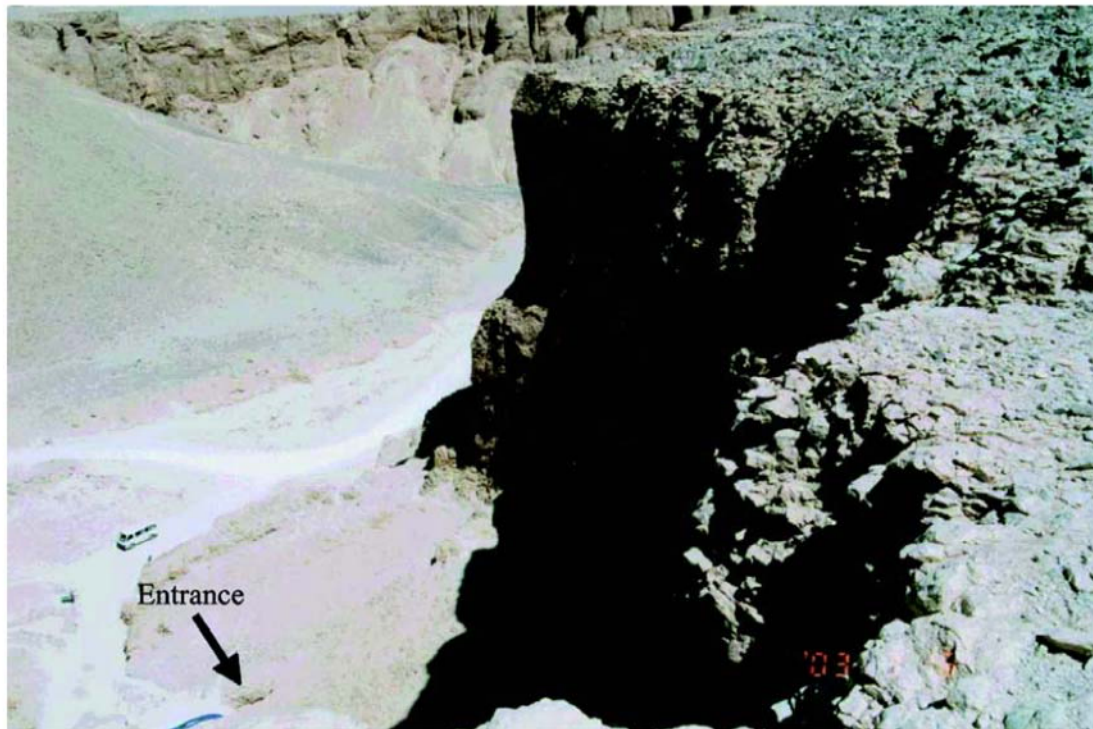
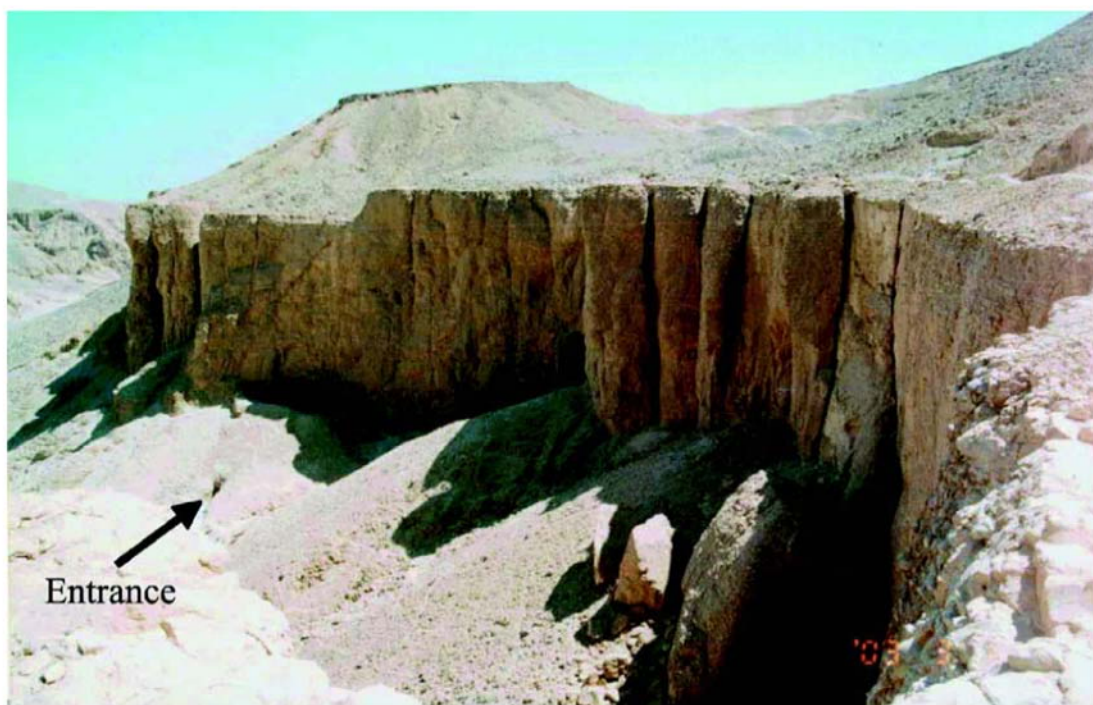
In addition to some instability problems in the tomb, the cliff over the entrance of the tomb presents some possible slope stability problems. Fig.54 shows some views of the open cracks observed at the hill over the tomb. These problems can be in the form of rockfalls or block toppling.

Fig.54 Some slope stability problems nearby the tomb entrance

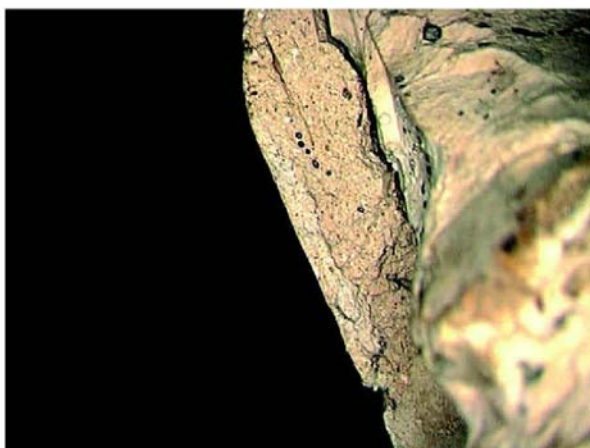
Fig.10 Three layers of plasters on the face of pillar 6
(Microscope)

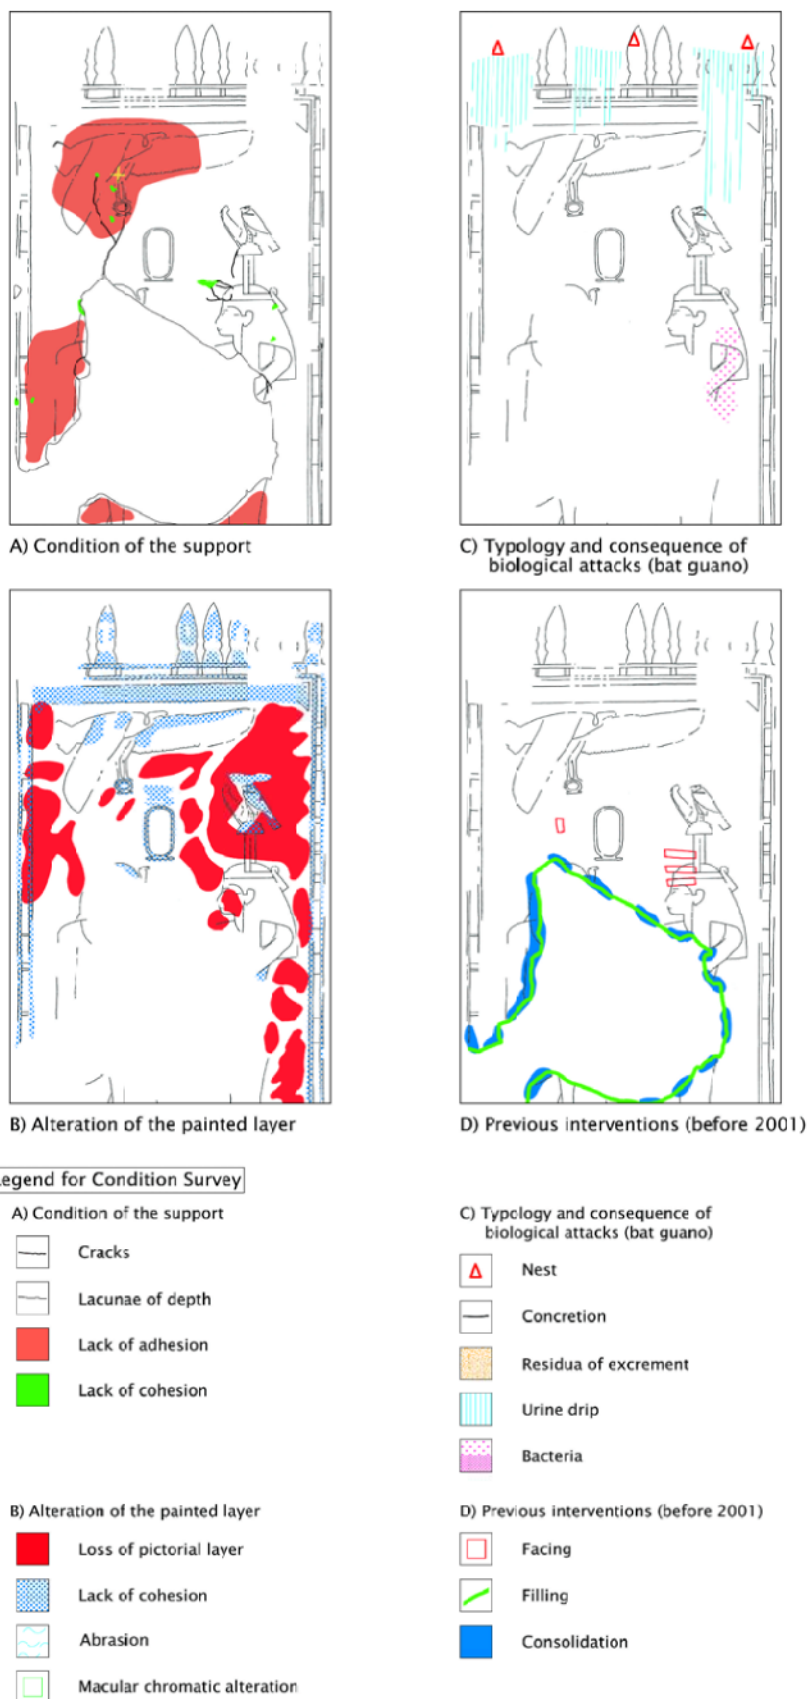
Fig.2 A example of sheets of the condition survey (not to scale)

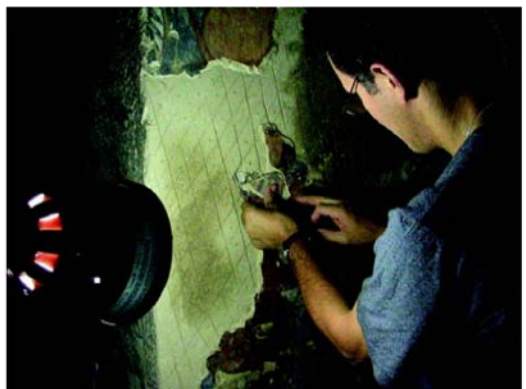
Fig.11 Reattachment of the fragment

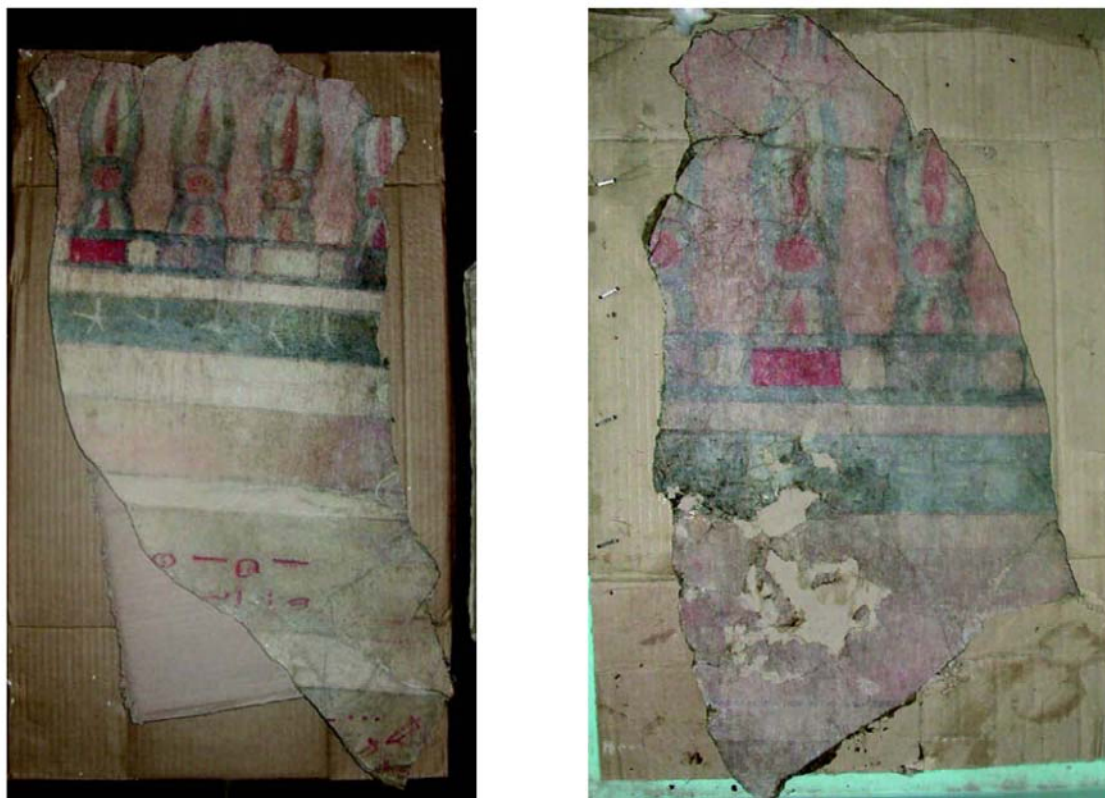
Fig.14 Detached fragments from the wall along the crack of the north wall in room J

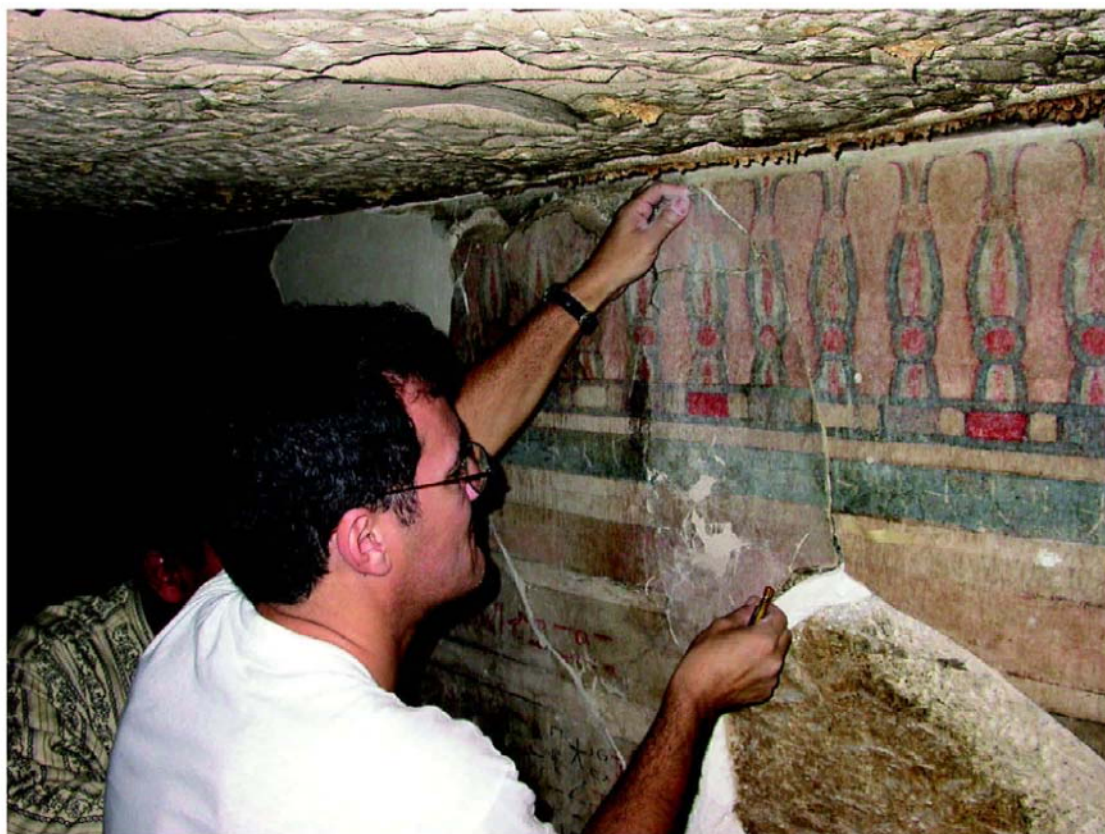
Fig.15 Execution of the reattachment of the fragments

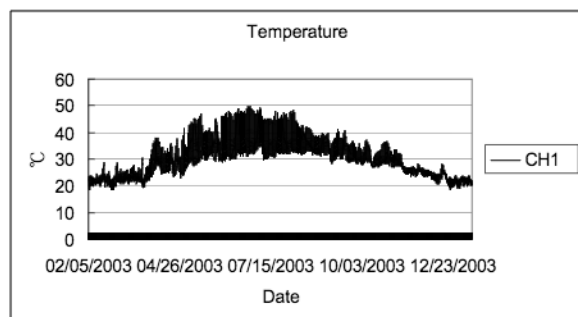
According to the data by which logging was carried out from the temperature-and-relative-humidity meter, a considerable difference could be observed through the year in room B (Figs.1, 2). Since the location of the logger was near the ground, or outside, it is considered that it could be easily influenced by the temperature and relative-humidity of the open air.

Fig.1 Temperature in room B

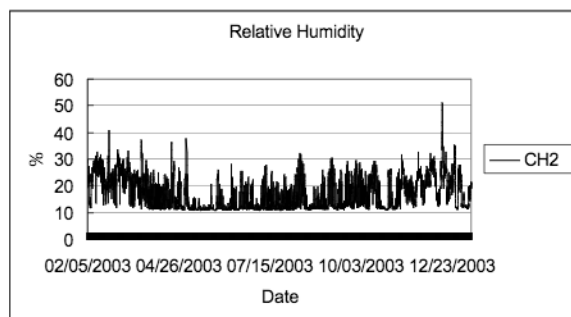
Fig.2 Relative humidity in room B

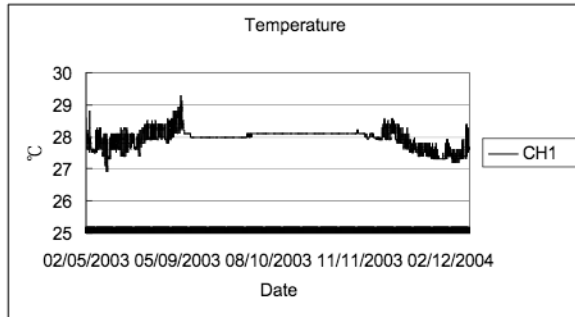
In room J, the change of temperature and relative humidity during the year was not as remarkable in comparison to room B (Figs.3, 4). The working conditions were improved by the introduction of fresh air or improvement of the exhaust environment.

Fig.3 Temperature in room J

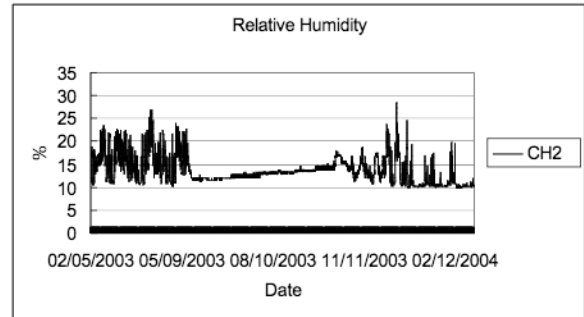
Fig.4 Relative humidity in room J

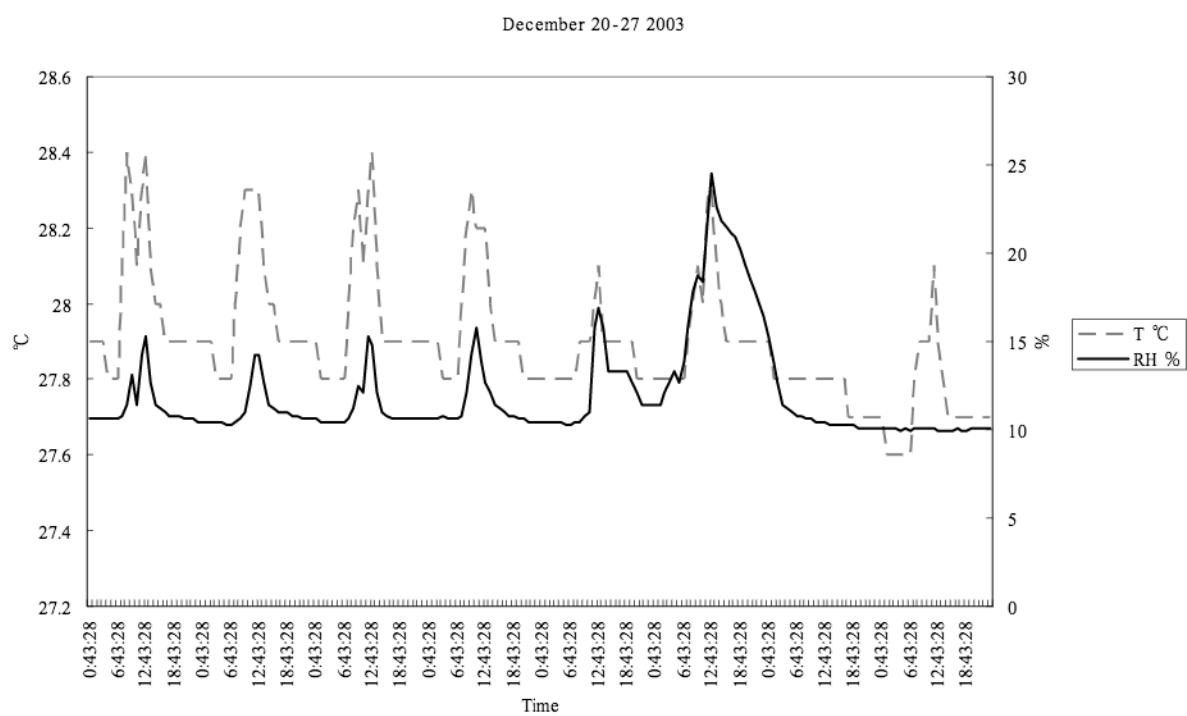
Fig.5 Temperature and relative humidity variation in room J during working days

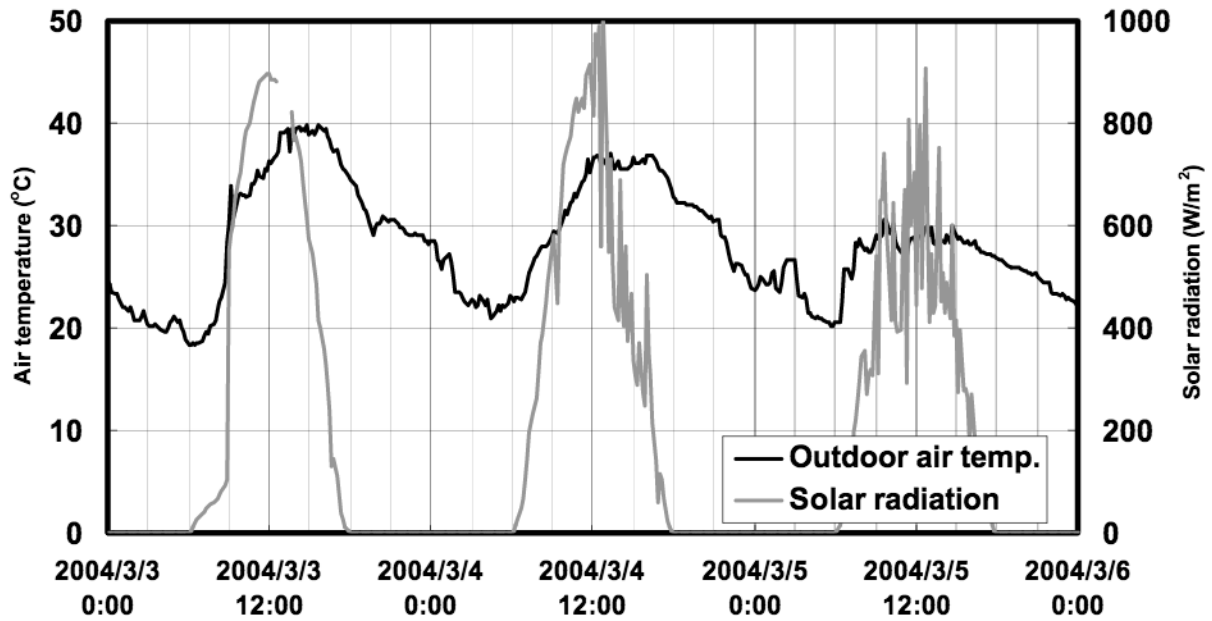
Outdoor air temperature and solar radiation measured during the survey are presented in Fig.2. Precipitation was not observed throughout the survey. Because of the dry geographical nature of the area, outdoor air temperature rose up to 40°C during the day, while it decreased to as low as 20°C at night. Relative humidity was 10-15 %rh during the day, and 20-30 %rh at night.

Fig.2 Outdoor air temperature and solar radiation

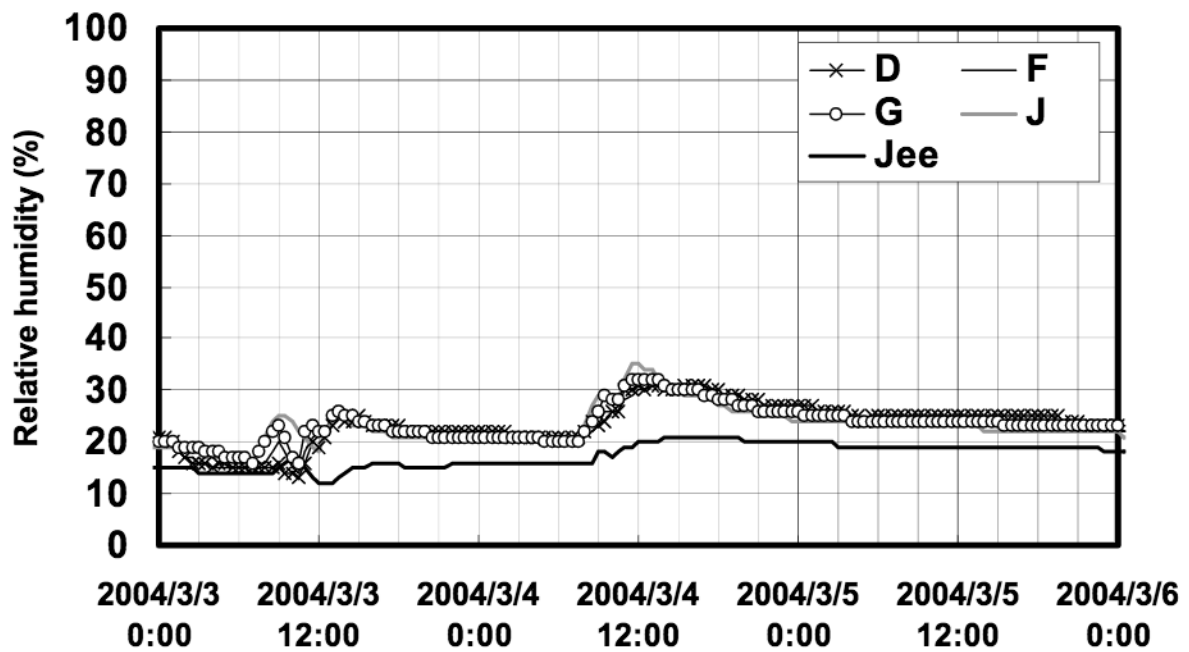
Fig.4 Relative humidity fluctuation inside the tomb

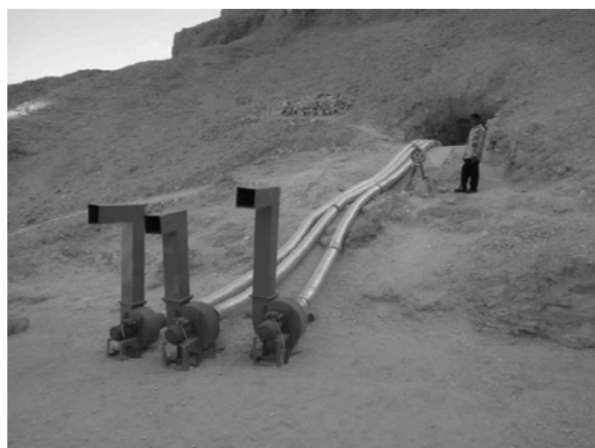
A survey was conducted to investigate the indoor environment of the royal tomb of Amenophis III under working conditions. Supply and exhaust fans provided the ventilation of the tomb at 0.8 1/h air change rate, and carbon dioxide concentration was satisfactorily low even compared to modern buildings. The indoor concentration of volatile organic compounds and other chemical substances was well below the acceptable limit proposed by the Japan Society for Occupational Health. The indoor working conditions were satisfactory with respect to human safety, and recommendations on ventilation should be made with regard to conservation of wall paintings. Further survey is required in this respect.

Fig.5 Supply and exhaust fans

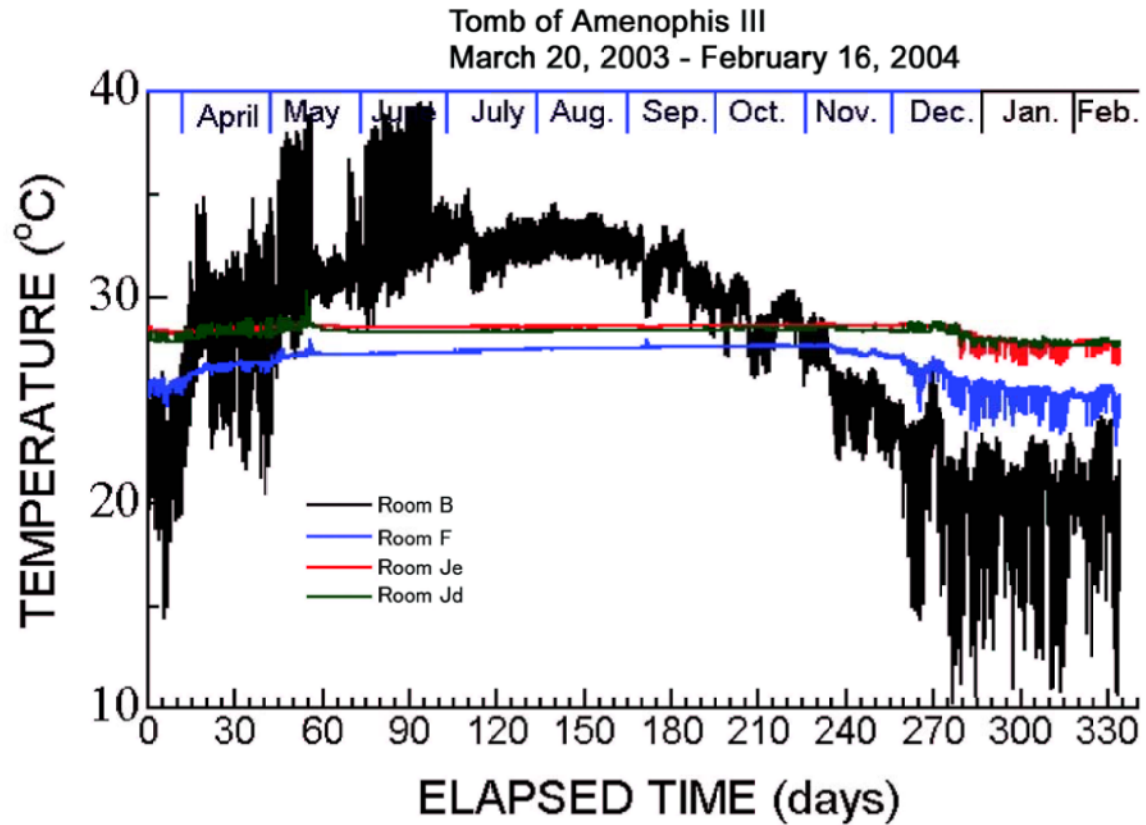
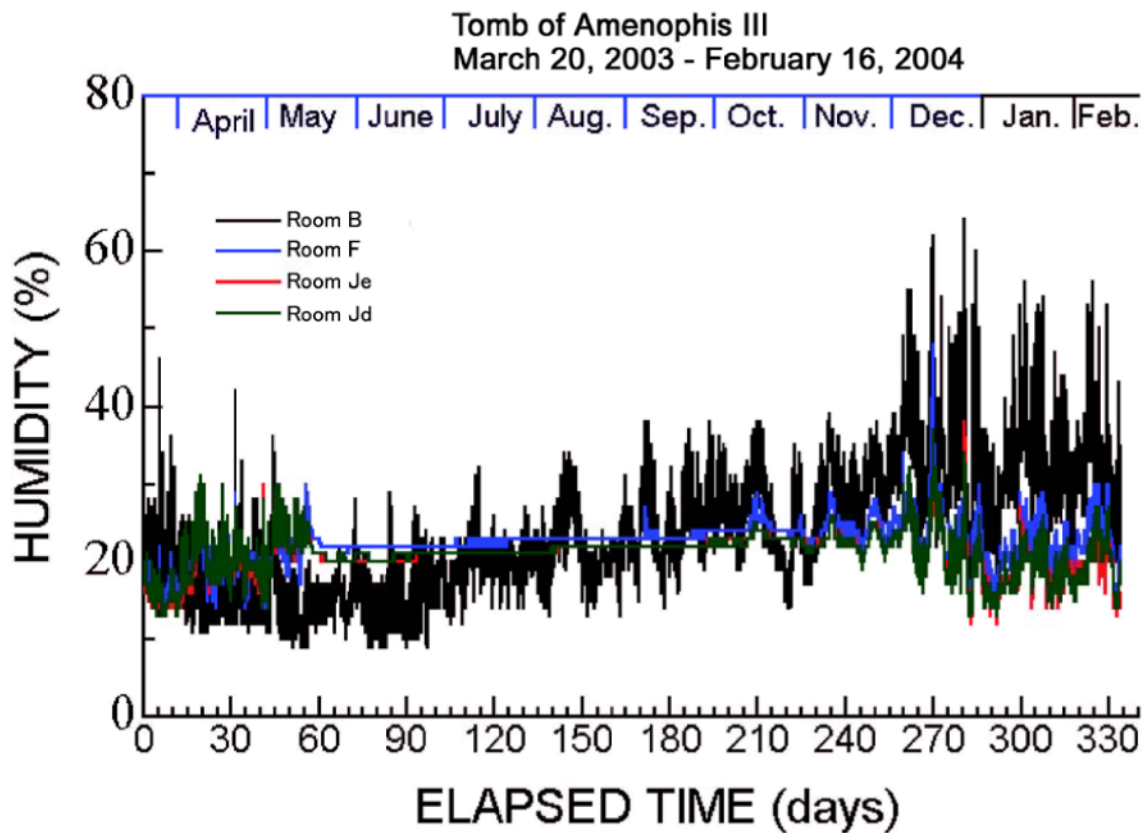
The mean humidity in room Je and Jd is about 20-22% when there is no human activity in the tomb. However, the daily fluctuations become very large and they range within 10 to 40%. The humidity of room F is higher, as it is directly connected to the entrance. The humidity variation at the entrance of the tomb ranges between 10 to 65% during the period of measurement. During summer, the humidity is lower, while it becomes larger during the winter period. In other words, June is the most dry month of the year while December is the most humid month of the year.

Fig.1 Temperature and humidity variations with time

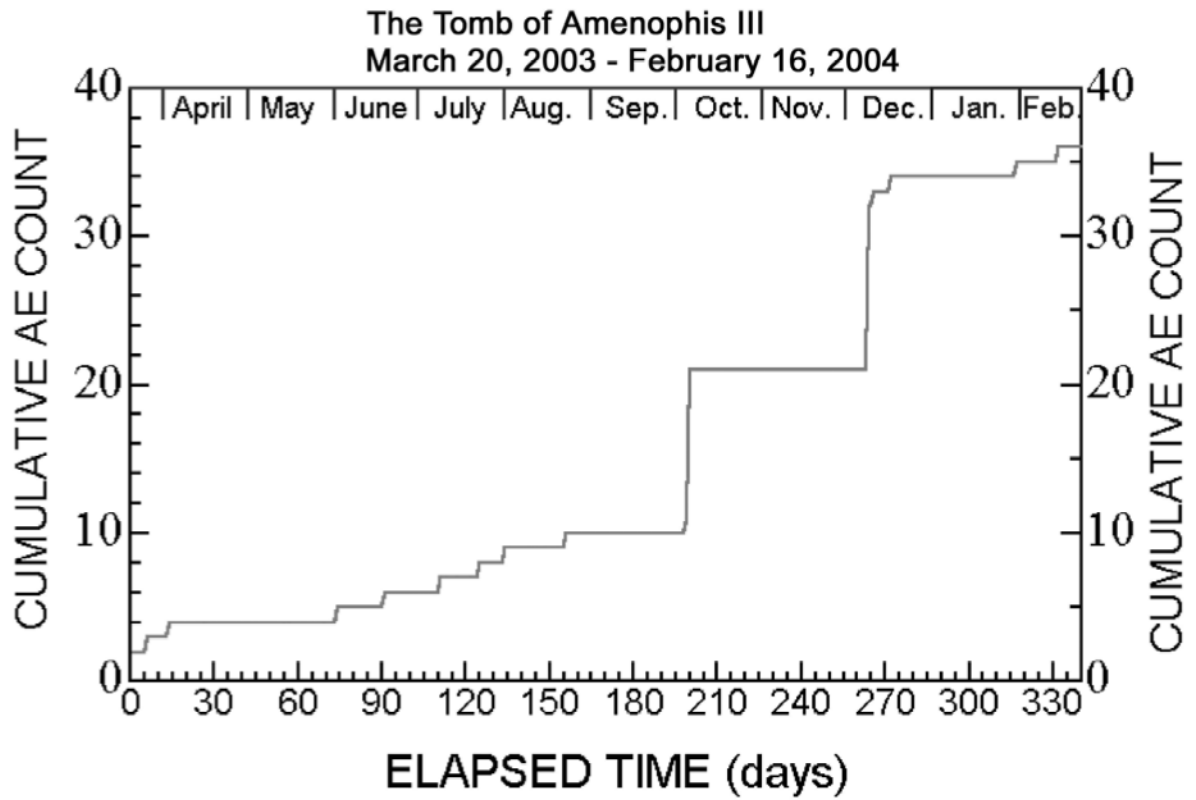
Fig.2 Acoustic Emission response of the sensor AE3 with time tomb

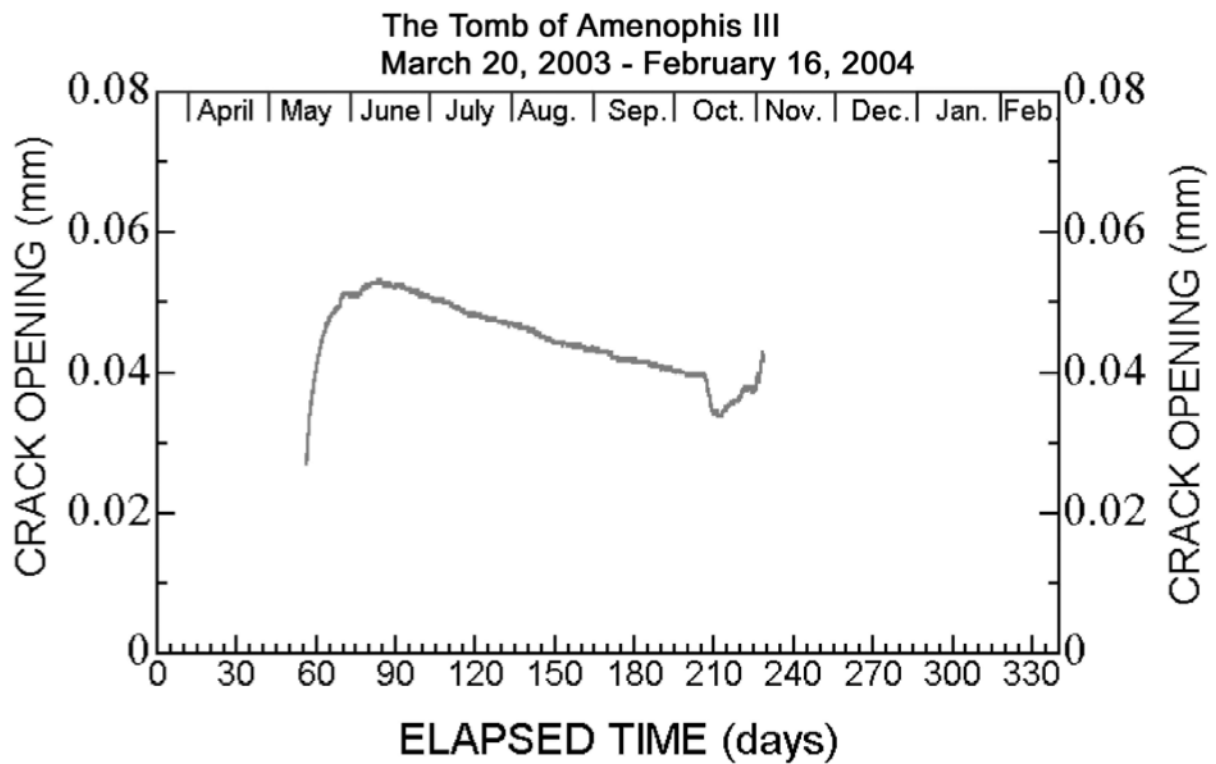
Fig.3 Displacement response of the fracture with time

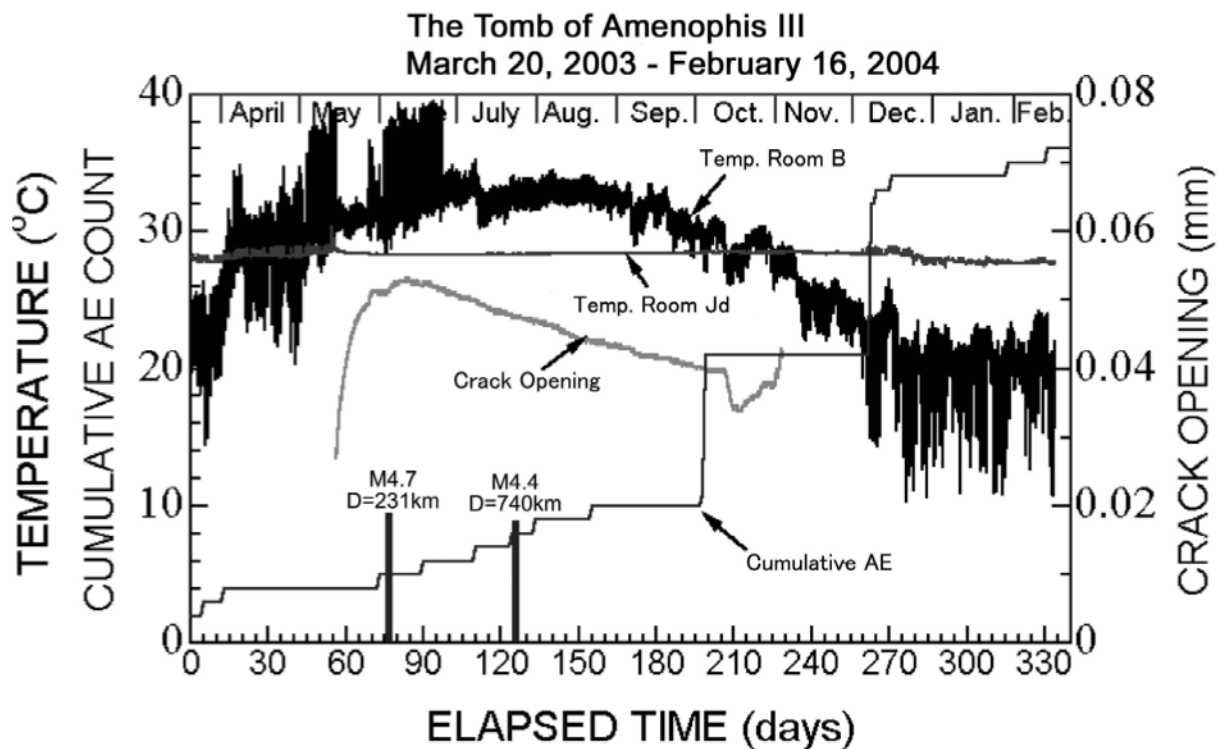
All relevant data are re-plotted in Fig.5 in order to discuss the implications of the measurement results from *in situ* monitoring systems. It seems that the acoustic emission activity started at the end of May 2003 has some relation to the seismic activity along the Nile River to the north of the tomb. If the outside temperature increases, the whole hill should expand. Consequently the inward closure of the tomb should occur, which subsequently may cause the opening of the fracture. On the other hand, if the outside temperature decreases, the reverse response should occur, provided that the surrounding rock behaves linear elastically. The sudden increase of AE activity and subsequent variation of displacement response simply implies that some new fracturing took place, and this further led to the opening of the fracture. In other words, there is a high possibility of further propagation of the existing fracture in the north wall of room J.

Fig.5 A comparison of parameters measured by *in situ* monitoring systems during the second phase

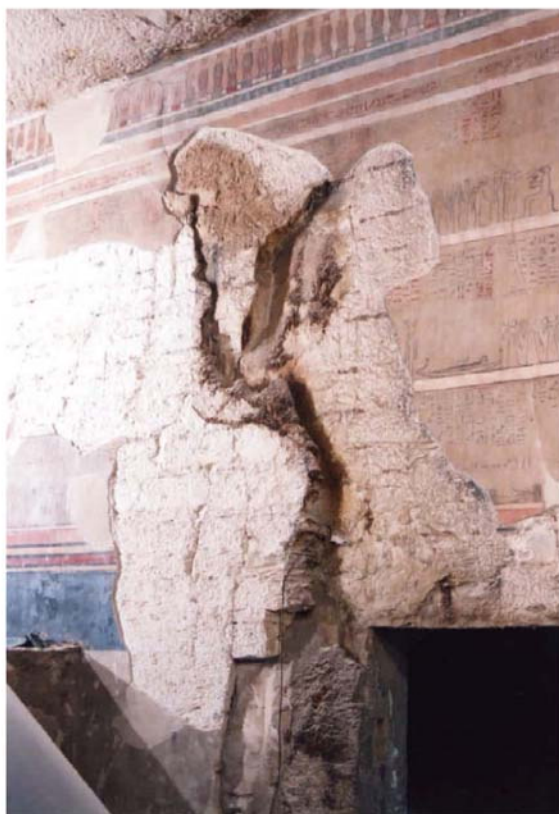
Fig.1 The crack in the wall between room J and Jd

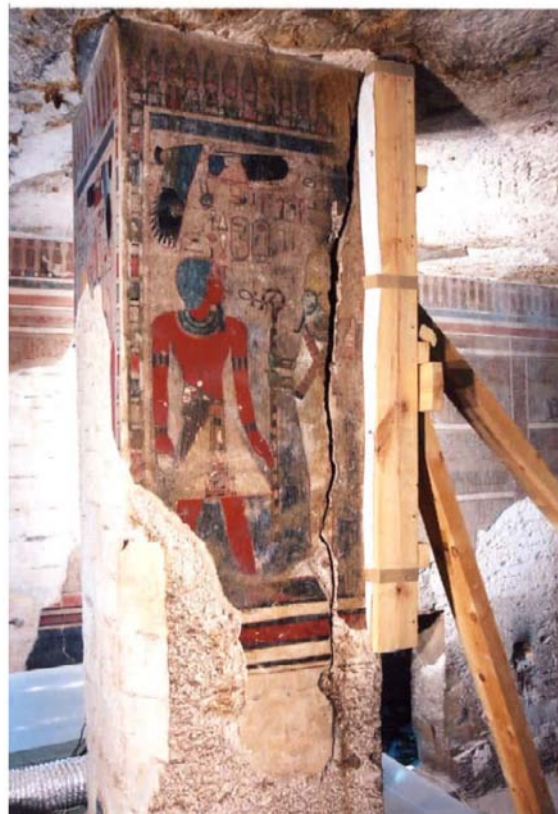
Fig.2 The situation of pillar 3 in room J
